Coastal Walkway Asset Management Plan 2020 - 2030

COASTAL WALKWAY ASSET MANAGEMENT PLAN

Coastal Walkway Plan

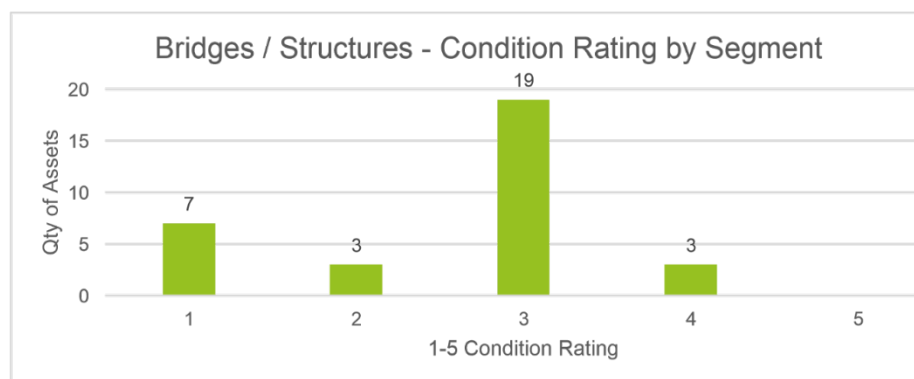
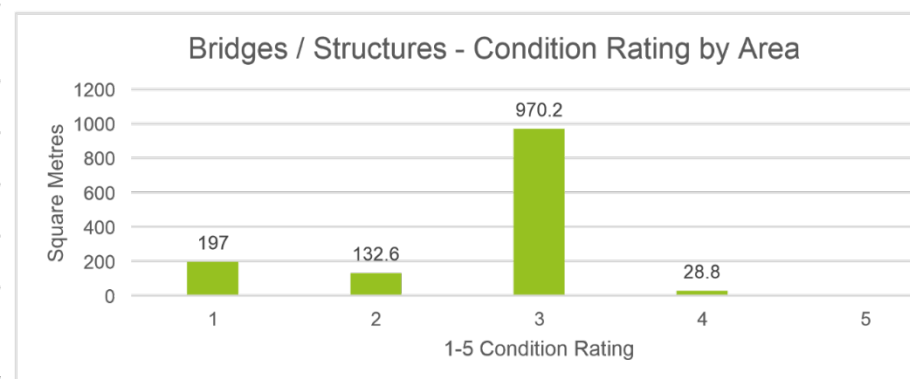
The rectification and renewal costs for Bridges and Structures far outweighed the remaining costs of the asset class pertaining to minor structures. As a consequence, a detailed Level 3 Bridge Audit Report focusing on these concerns added to the scope of the audit.

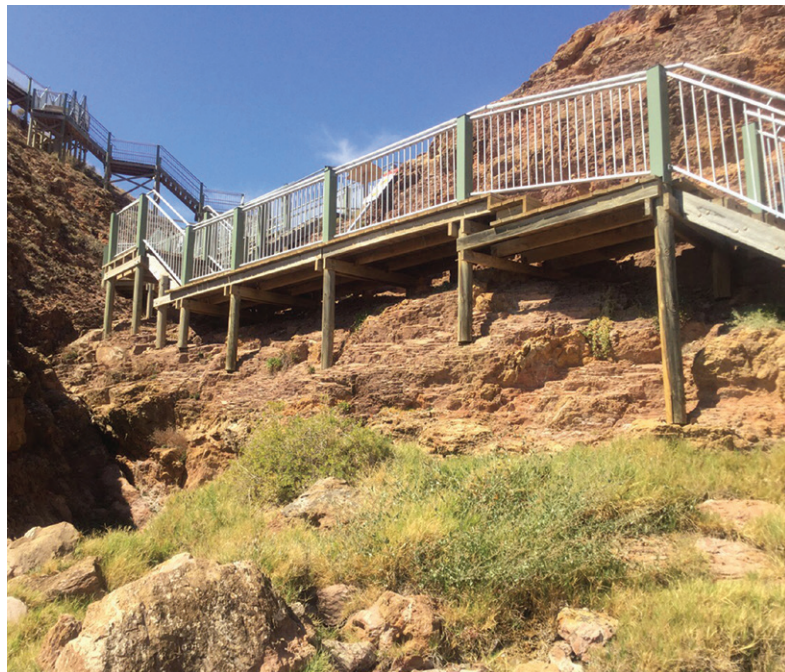
Twelve elevated timber walkway structures along the walkway were rated as high risk, due to the lack of information on the adequacy of the footings. It was recommended that intrusive investigations involving earthworks, geotechnical inspections and structural assessments be undertaken to determine the condition of repair and / or replacement options.

Approximately 560 footings were inspected across the twelve large timber structures. Due to the age of the asset, a management plan to manage these structures for the next 10 years has been developed.

The investigations concluded the coastal cliffs are a fragile environment for the walkway. Stormwater runoff combined with erosion and climate change have had an extreme impact on the structures' footings. A detailed report will be brought to Council in November, including the cost of future repair work and when the sections are likely to be re-opened.

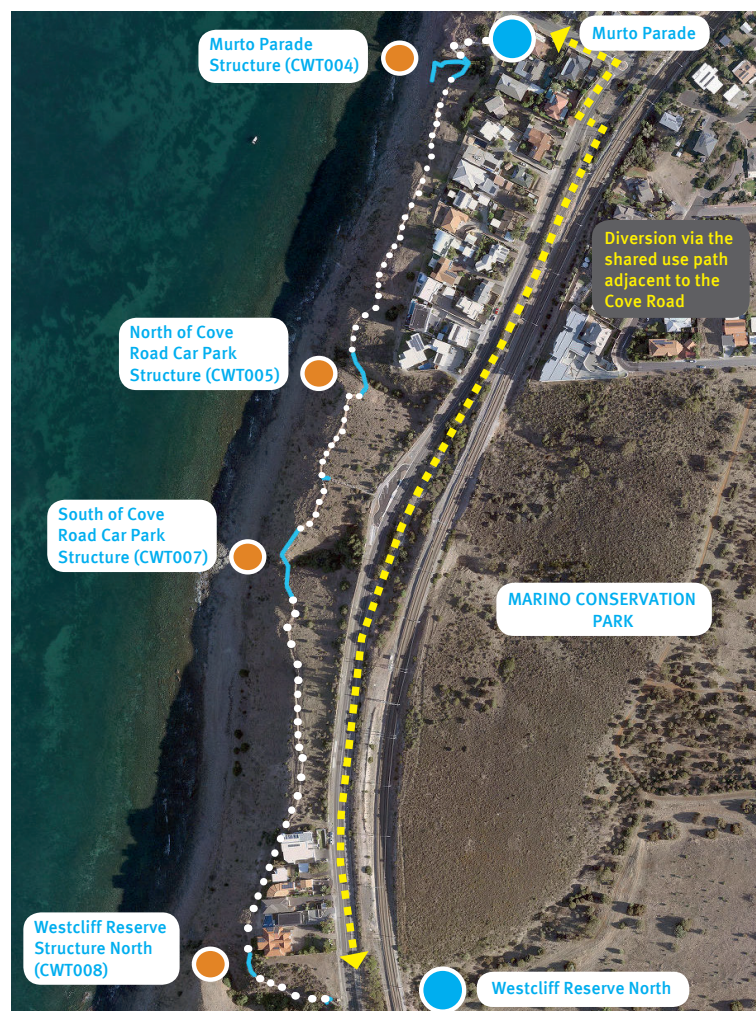
CELL 3 | COVE ROAD LOOKOUT | 0.95KM

- **Existing Infrastructure:** Combination of natural rocky ground surface, timber structured staircases and bridges and newly replaced Fibre Reinforced Polymer steps / platforms. Beach access from CWT004 timber structure is to be decommissioned.
- **Aboriginal Cultural Heritage:** Unknown Aboriginal cultural heritage throughout this Cell segment.
- **Biodiversity:** Significant coastal heath vegetation to be protected and conserved.

- **Access Node Connectivity:** Access can be made from Murto Road and links occur from both Cove Road carpark and Westcliff Reserve in the southern portion of the Cell.
- **Natural Element Remediation:** Severe erosion occurring within Murto Road gully due to stormwater outlet. Minor repairs of steps utilising FRP due to water erosion. Further works needed.
- **Biodiversity Management:** Continued programmed management in place to conserve native flora species & to perform weed control of this protected flora within this Cell.
- **Kaurna Heritage:** No registered Kaurna Heritage sites.
- **Access Considerations:** Access is not possible throughout this cell for vehicles and heavy machinery.

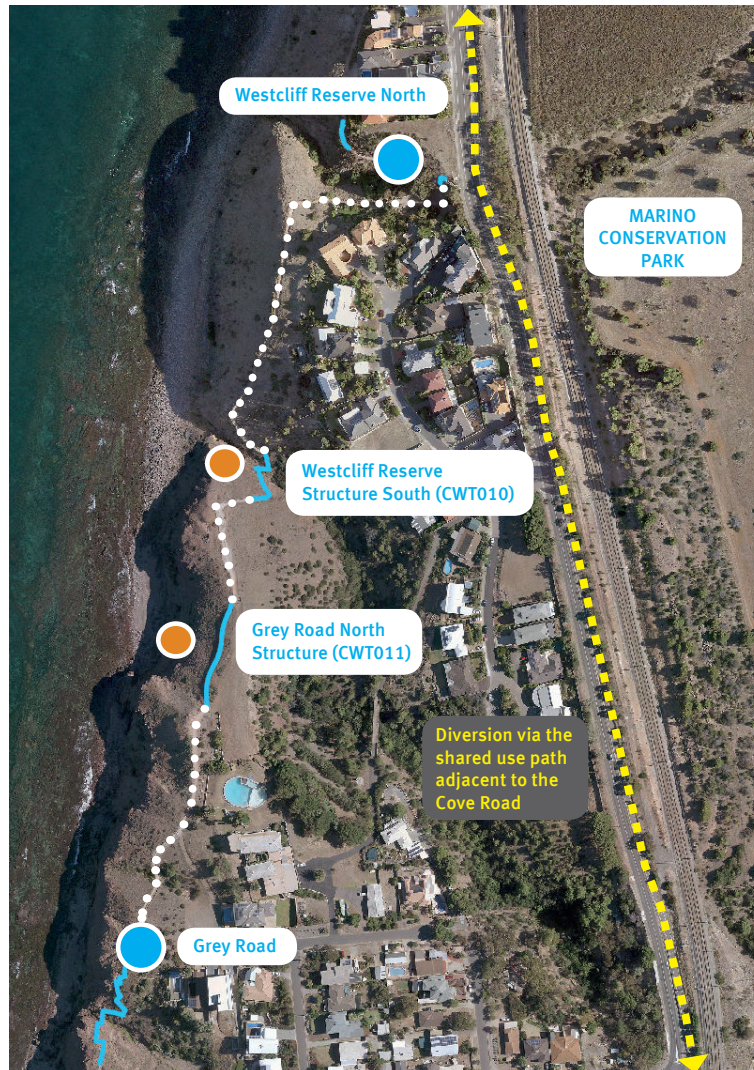
CELL 4 | WESTCLIFF | 0.63KM

- **Existing Infrastructure:** Combination of natural rocky ground surface, timber structures and steps with some replaced Fibre Reinforced Polymer trail platforms.
- **Aboriginal Cultural Heritage:** Unknown Aboriginal cultural heritage throughout this Cell segment.
- **Biodiversity:** Some native vegetation needing to be considered throughout coastal cliff zone & within gully alignment.
