10.1 Coastal Walkway Gullies Report for Construction

Report Reference GC221213F10.1

To provide Council with an update on the Coastal Walkway Project for Grey Gully (Segment 5) and Kurnabinna Gully (Segment 6).

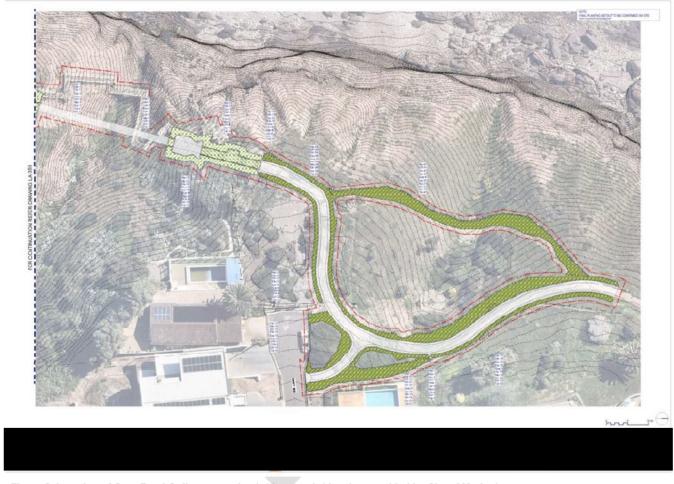
Figure 2. Location of Grey Road Gully suspension bridge, north (drawing provided by City of Marion).

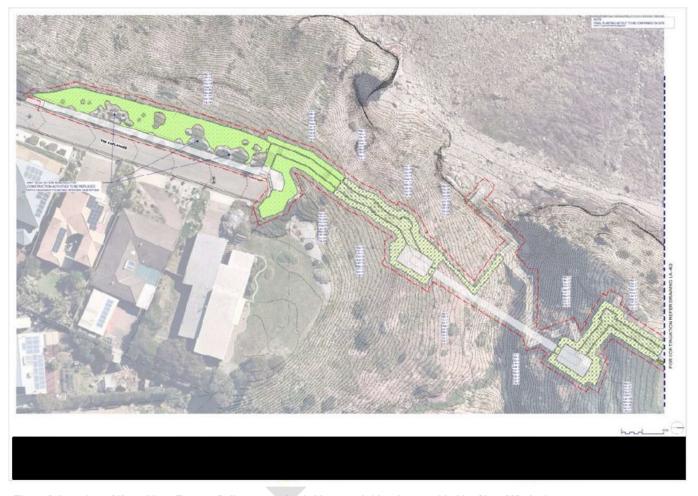
Figure 3. Location of Kurnabinna Terrace Gully suspension bridge, south (drawing provided by City of Marion).
