# Coastal Management Study

## Hallett Cove, SA

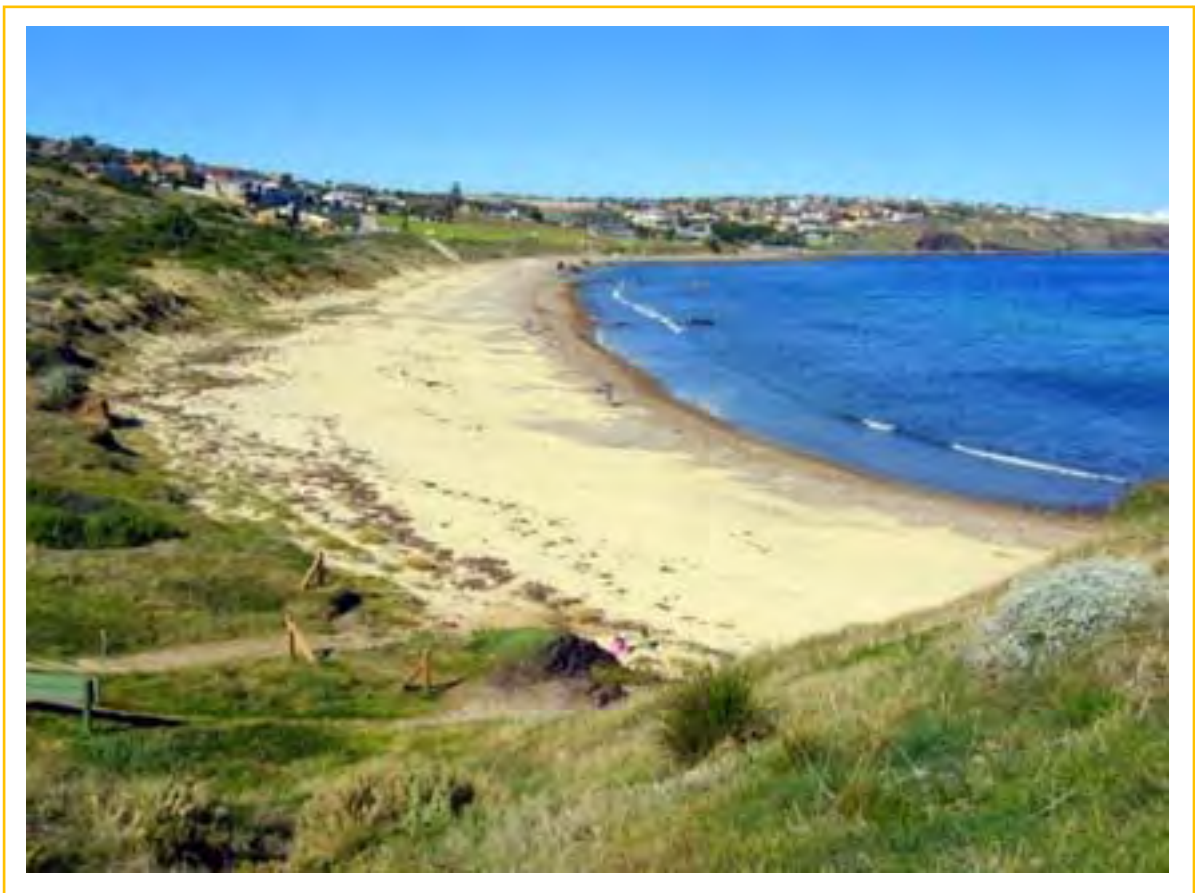
**Cover photo:** Hallett Cove 2011 as viewed from Black Cliff. The conservation area and foredune can be seen in the left-hand foreground. Heron Way Reserve and the Field River entrance are in the centre background. The Hallett Headland and the cliffs south of the Field River to the desalination plant are in the background. Photo is from a similar location to the 1971 photo at Plate 2-4.

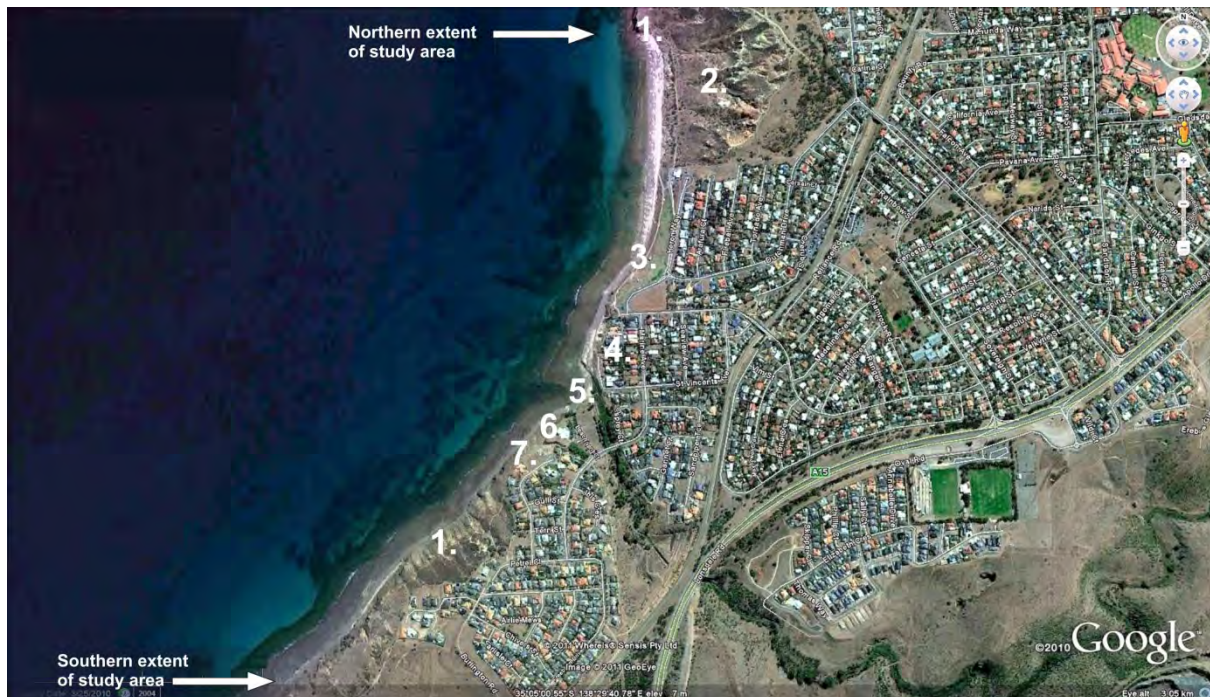
**Plate 0-2:** The extent of Hallett Cove foreshore in the study area, 2010. Numbered sites refer to notes below.  
**Photo source:** Google Earth image based on aerial photography 25 March 2010

Hallett Cove is located within the City of Marion towards the southern end of the Adelaide metropolitan coast and is approximately 12km south of the Glenelg jetty. The study area is defined in the project brief as 'the section of the Hallett Cove foreshore between the southern border of the Council area and the northern section of the beach directly in front of the Hallett Cove Conservation Park (section approximately 2.5 km)' and is shown in Plate 2-2.

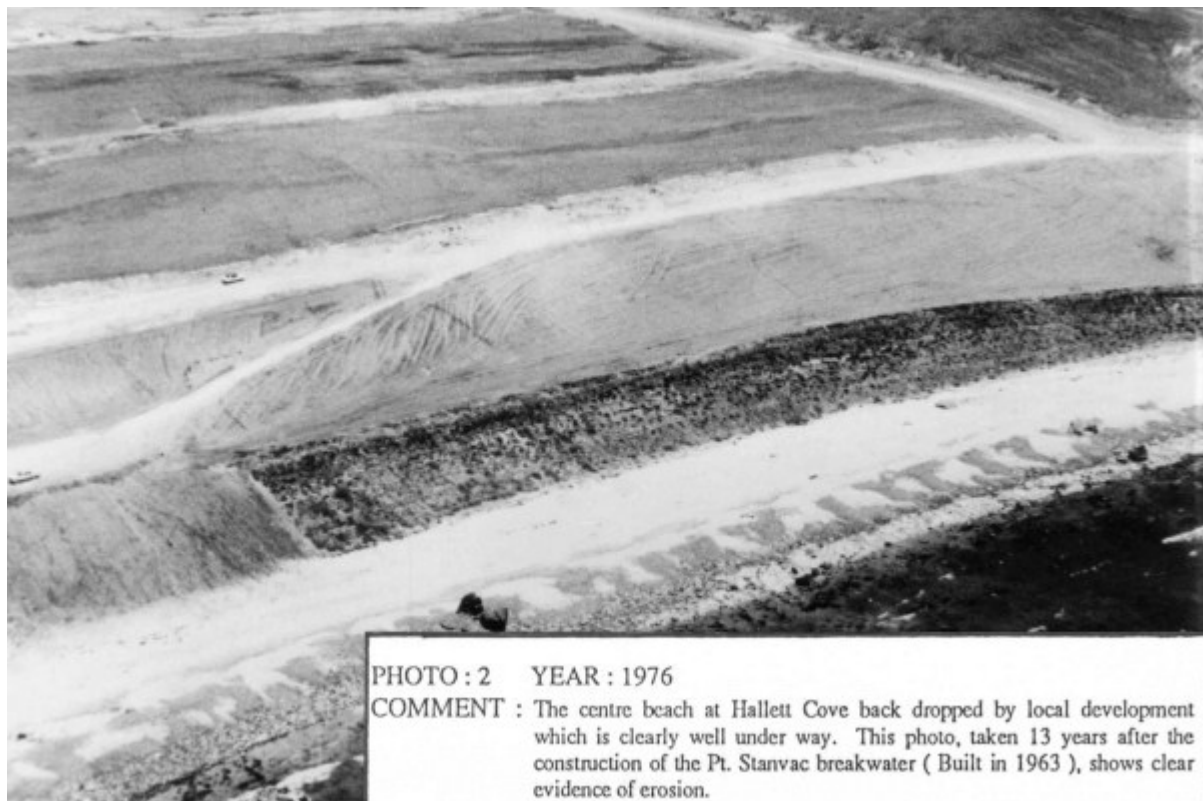
**Plate 0-3:** Earthworks for the Hallett Cove subdivision, 1976. The two large rocks on the beach (see Plate 2-8) can be seen. The left-hand lower track is the road leading to the present day car park. The Boatshed Café would be approximately at the left-hand side of the photo. All the back beach area has been re-contoured and the outline of what is now Heron Way Reserve can be seen behind the beach. **Source:** unknown, from Matschoss & Mayberry (1993)

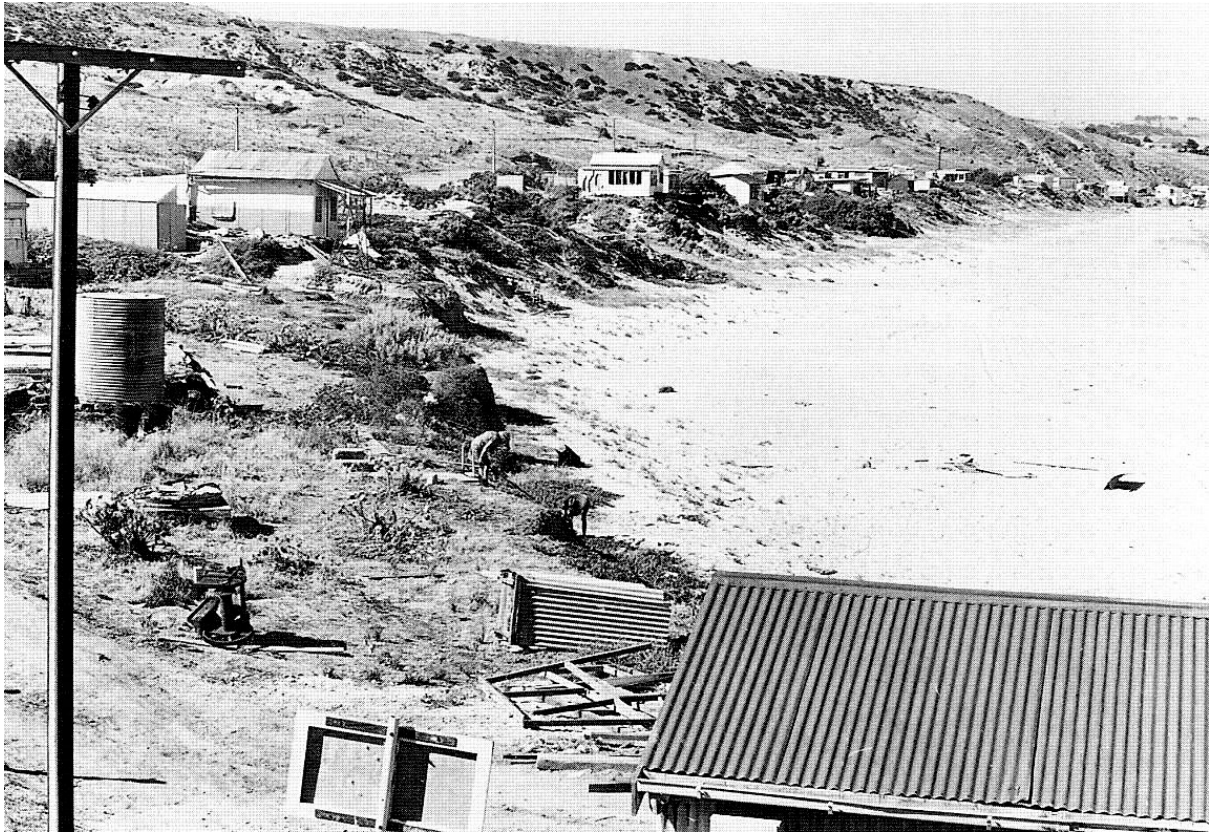
**Plate 0-4:** Hallett Cove, 1971 showing shack development along the front of the present-day Conservation Area. The photo is taken from the beach dune near Black Cliff at the location of the then Surf Life Saving Club which originally operated from one of the shacks. **Photo credit:** Wally Herzfeld as reproduced in Donley 2001, p. 166

The development of the area required removal of the shack development. The extension of the amphitheatre to the south where it joins the beach on the north side of the Field River entrance can be seen in the background of the 1971 photograph (Plate 2-4). This section of the amphitheatre was subsequently filled and levelled by the earthworks undertaken to establish the subdivision at Hallett Cove and the creation of Heron Way Reserve (Plate 2-3).

The Hallett Cove Surf Club was initially established in one of the shacks at the northern end of Hallett Cove, near Black Cliff (Plate 2-4). The club remained in this location until around 1980 when it relocated to a purpose-built building further south, at the end of Heron Way adjacent to the Conservation Area. The Hallett Cove Surf Club ceased operation in 2003 due to a loss of members to adjacent clubs where the beach conditions were preferred. The City of Marion subsequently considered options for the reuse of the club building which is now leased and operating as the Boatshed Café since 2007.

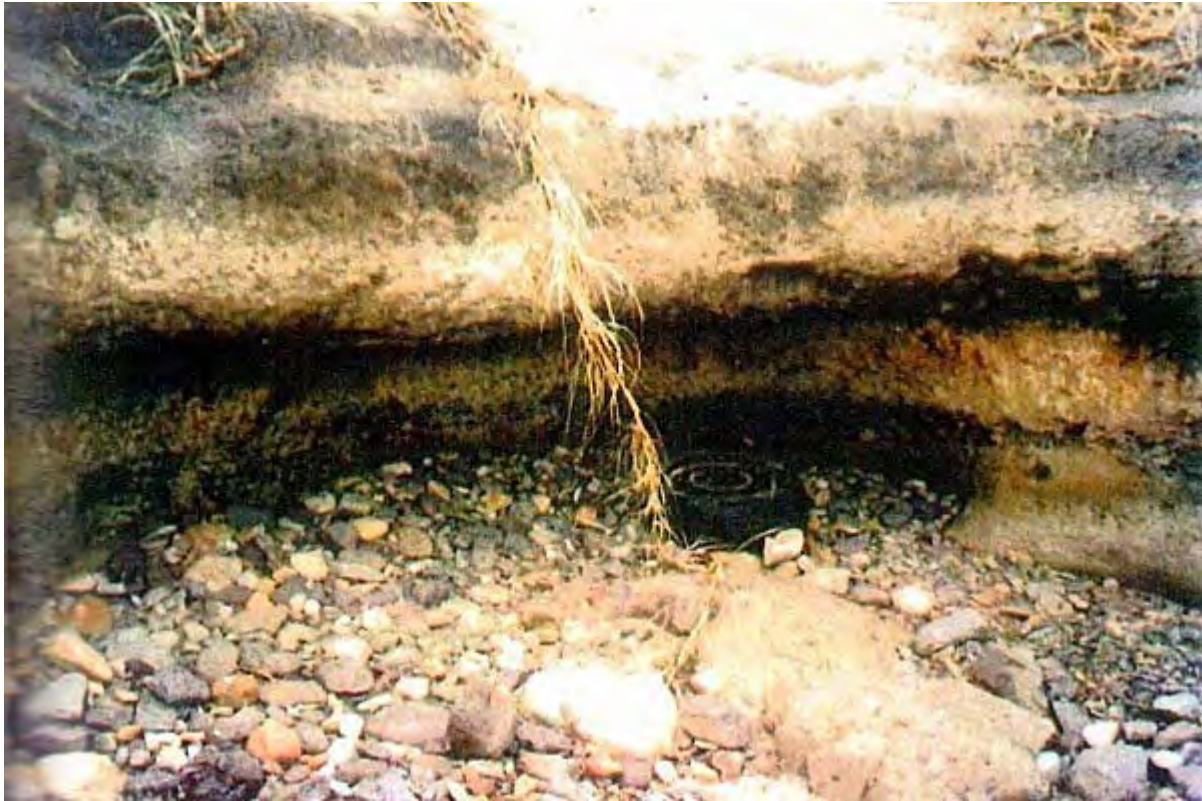
**Plate 0-5:** Undercutting of the dune south of Field River entrance, 1999. The dune is a thin sand cap overlying the clay substrate. During elevated water levels and high waves the clay layer is eroded forming caverns beneath the dune which are prone to collapse. **Photo credit:** A&S Elia, 1999

(Plate 2-5) along the back beach which are dangerous and can collapse. The City of Marion took preventative action to collapse these caverns.

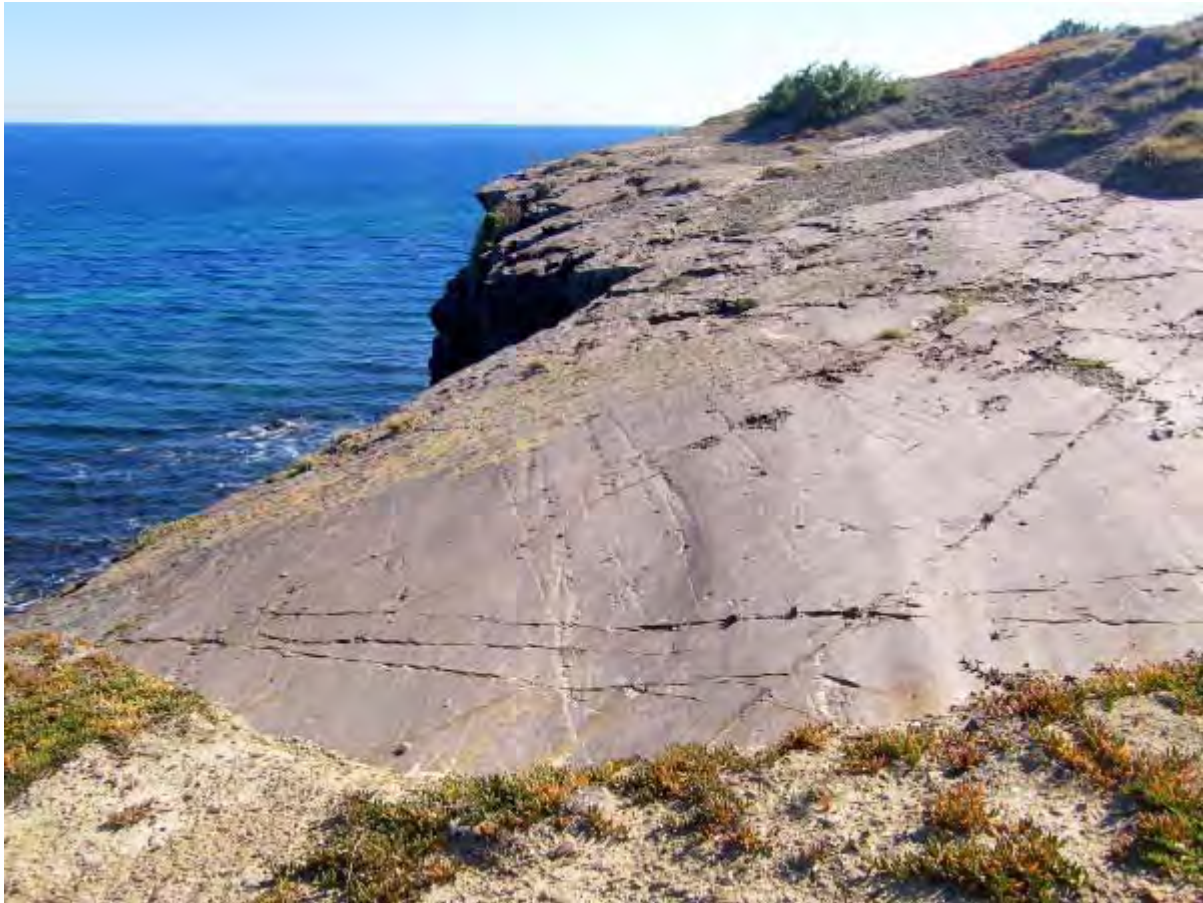
**Plate 0-6:** Exposure of 600 million year old Precambrian siltstones at the top of Black Cliff, Hallett Cove. The polished surface and deep scratches caused by the passage of a glacier approximately 270 million years ago were first recognised by Professor Ralph Tate of the University of Adelaide in 1877. **Photo:** Coastal Environment Pty Ltd, 27 April 2011

This glaciation, which was evident along approximately 2km of the cliff shoreline, has subsequently been identified as the result of a glacier traversing the area from south to north in the Permo-Carboniferous age (Hasenohr & Corbett 1986), almost 270 million years ago. Striations in the basement rock caused by scratches from rocks embedded in the glacial ice are visible on the rock shelf at the cliff top near Black Rock at the northern end of Hallett Cove (Plate 2-6). The Precambrian surface of these purple siltstones (believed to be some 600 million years old) was polished and scratched by the movement of the glacier. These Precambrian sandstones and siltstones of the Marinoan Series are exposed today as the cliff line reaching north from Black Cliff and as the lower level rocky shoreline platform at the base of the cliffs. They are exposed once more along the cliff line to the south of Hallett Cove (Hasenohr & Corbett 1986).

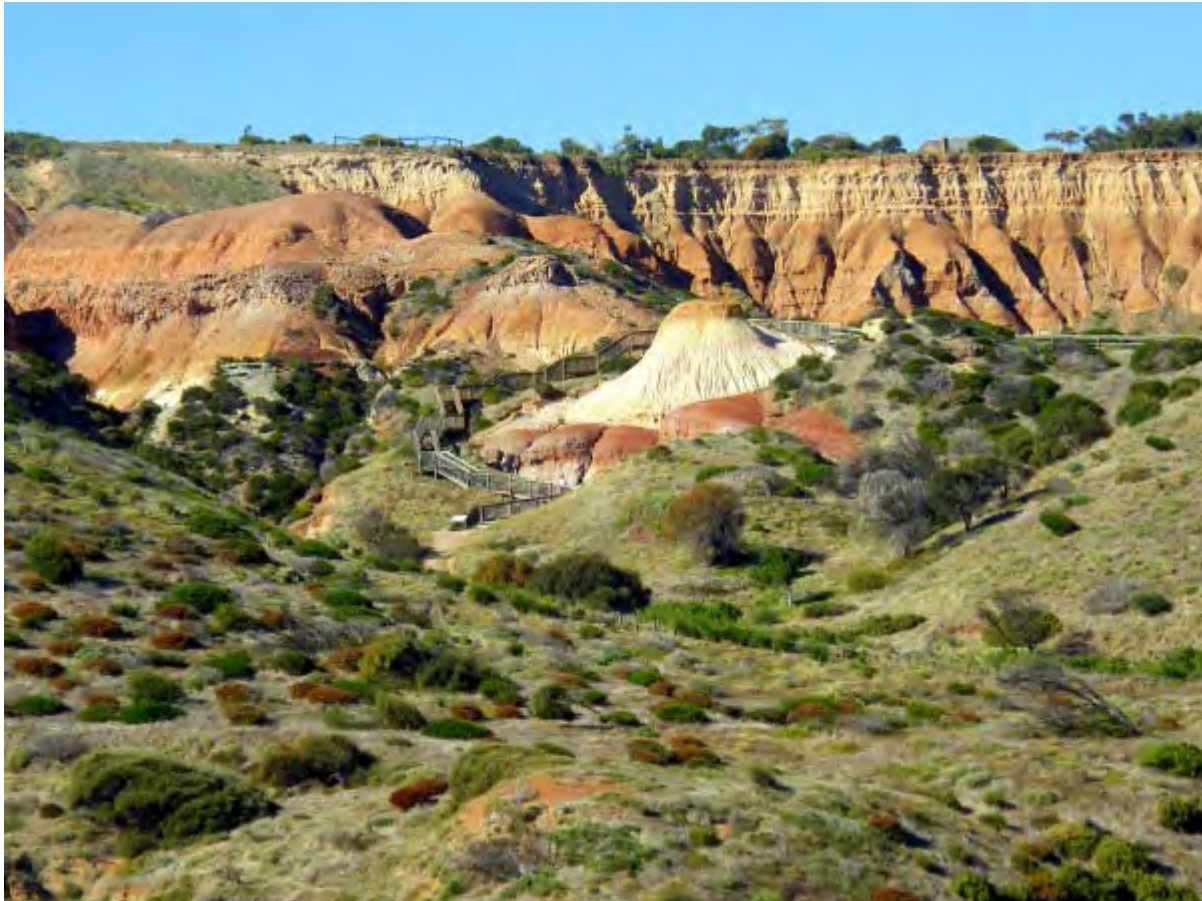
**Plate 0-7:** The sugarloaf and amphitheatre within the Hallett Cove Conservation Area 2011. **Photo:** Coastal Environment Pty Ltd, 27 April 2011

Following the retreat of the glacier, sediments were deposited along its route, infilling an old river valley that formerly occupied Hallett Cove. The nature of these Permian sediments within the amphitheatre area (Plate 2-7) suggests they were deposited in a lake formed by melt water trapped behind the retreating ice towards the end of the glaciation (Hasenohr & Corbett 1986). 'The soft Permian glacial deposits, overlaid by more recent clays, became in time deeply eroded, gradually carving the formation now known as the "Amphitheatre."' (Dolling 1981).

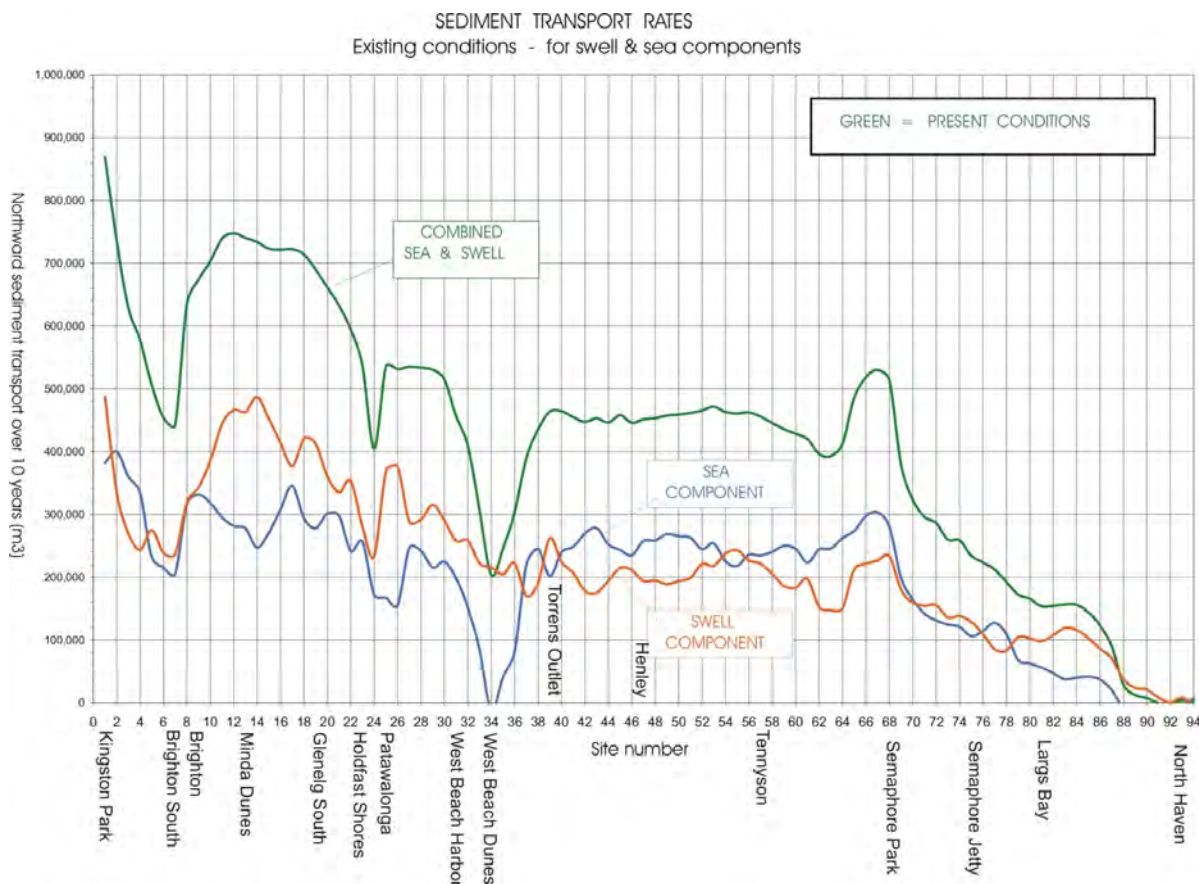
**Figure 3.1:** Modelled potential net northerly sand transport along the Adelaide metropolitan coast over 10 years. Reproduced from CES (2004), Figure 4

The alongshore sediment transport potential was computed by CES (2004) based on 10 years of hindcast wave data and the results are presented here from that report as Figure 3.1. This computation is based on the existing conditions (2002) including such things as seagrass distribution, shoreline protection works and existing bathymetry. Further computations were also undertaken for the time periods of 100 years BP and 20 years, 50 years and 100 years into the future. This modelling incorporated known changes to the sea bed, seagrass distribution and protection works and for the future projections, the addition of sea level rise based on recent (at the time the report was

prepared) CSIRO advice of 0.1m, 0.2m and 0.5m respectively. The historic and forward projections of potential sediment transport rates, result in minimal (local) changes to the overall sediment transport potential through the system over time.

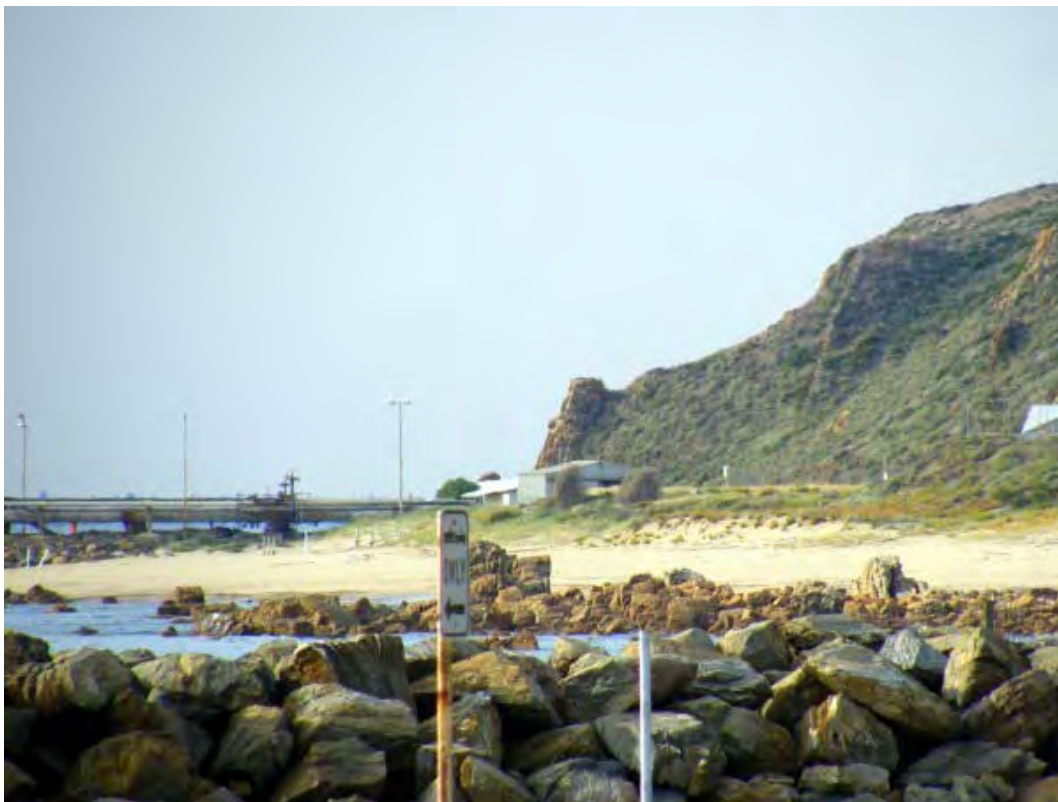
**Plate 4-2:** Port Stanvac from O'Sullivan's Beach boat ramp showing sand accretion on the southern side of the harbour. **Photo:** Coastal Environment 28 April 2011

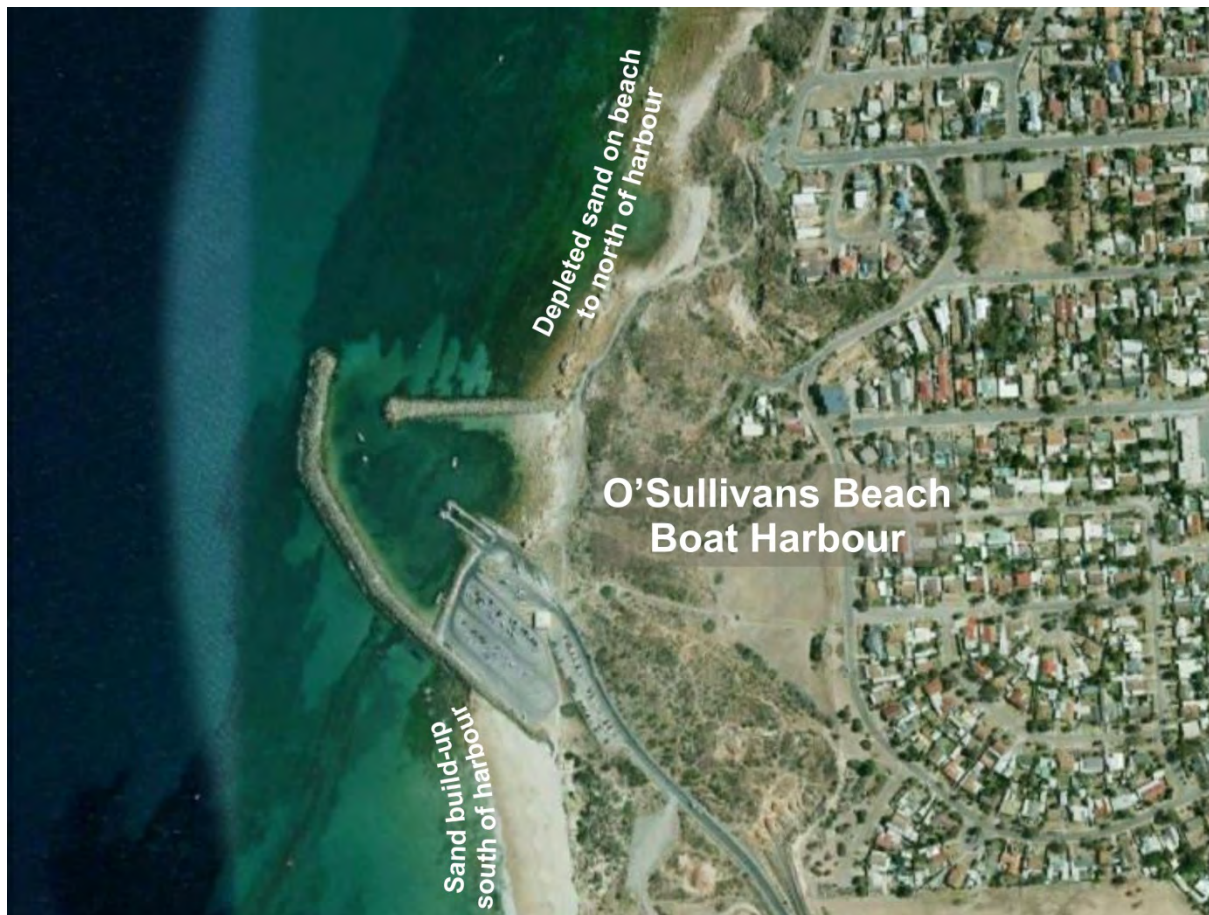
**Plate 4-3:** O'Sullivan's Beach boat harbour and ramp. The construction of the rock harbour walls has intercepted the alongshore sand movement, with accretion to the south and within the harbour. The beach to the north of the harbour is comparatively depleted of sand. **Photo source:** Google Earth image based on aerial photography 25 March 2010

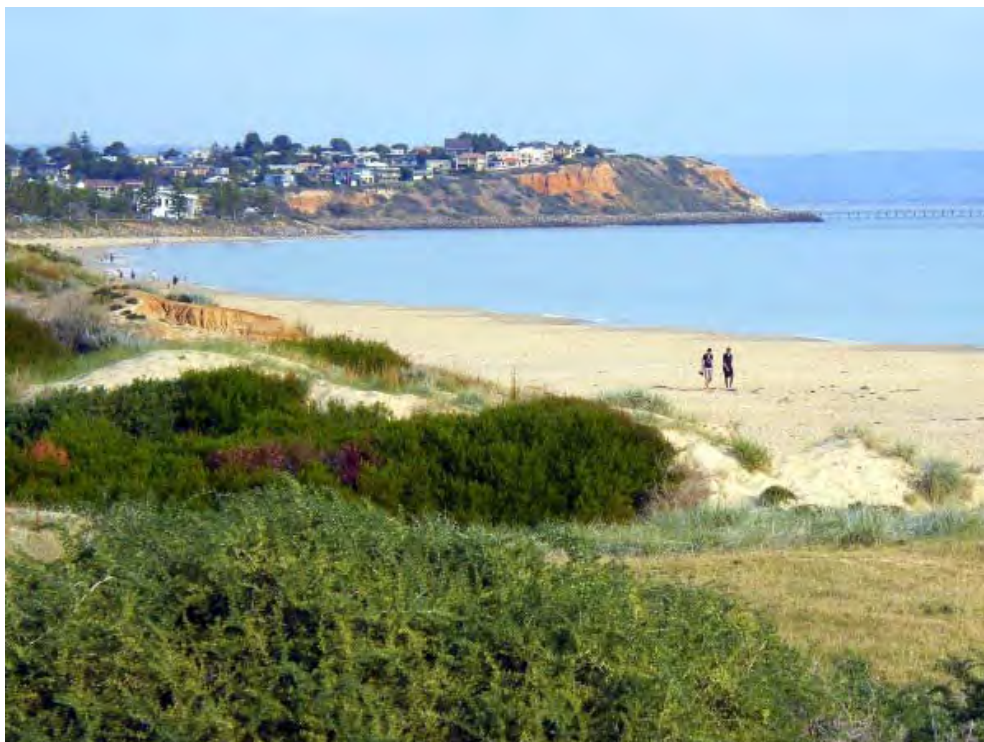
**Plate 4-4:** View south from O'Sullivan's Beach boat ramp showing the sand build-up. The rock protection along Christies Beach and Witton Bluff can be seen in the background. **Photo:** Coastal Environment 28 April 2011

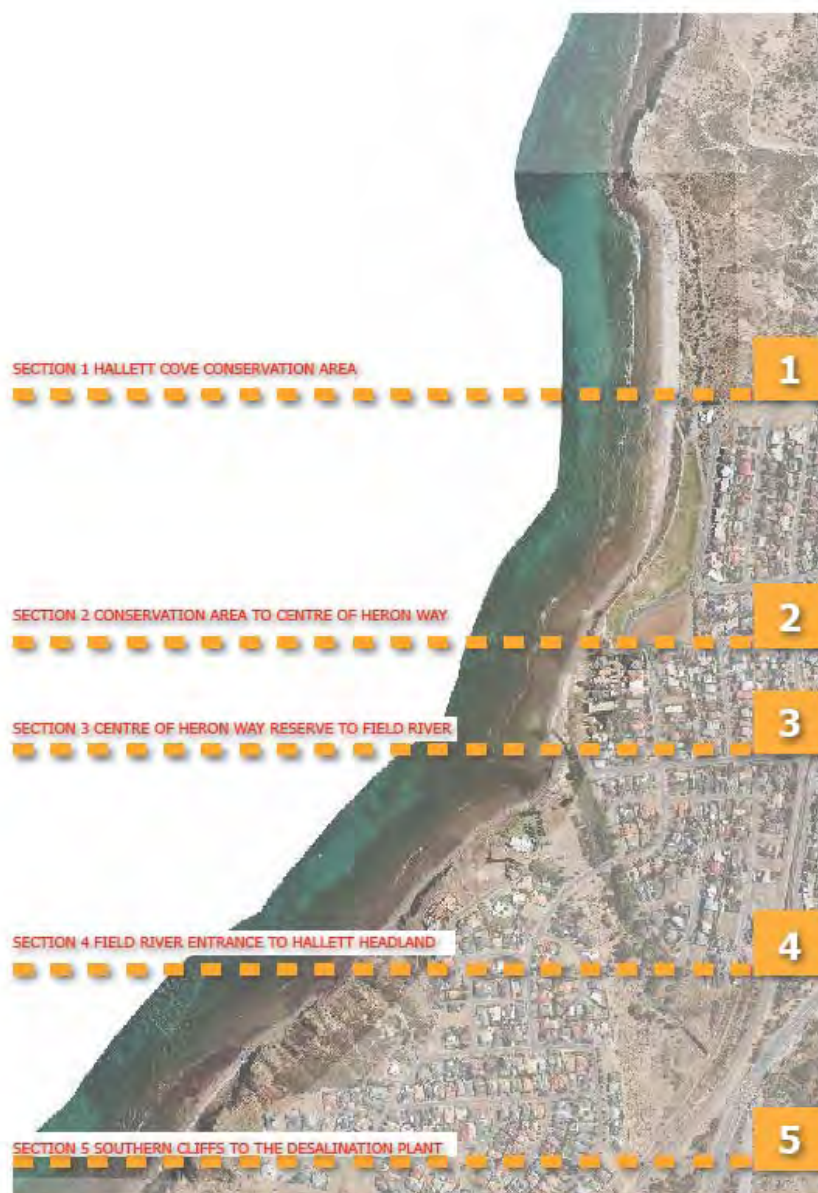
**Plate 4-5:** The study area has been divided into five sub-areas as described in the following sections.

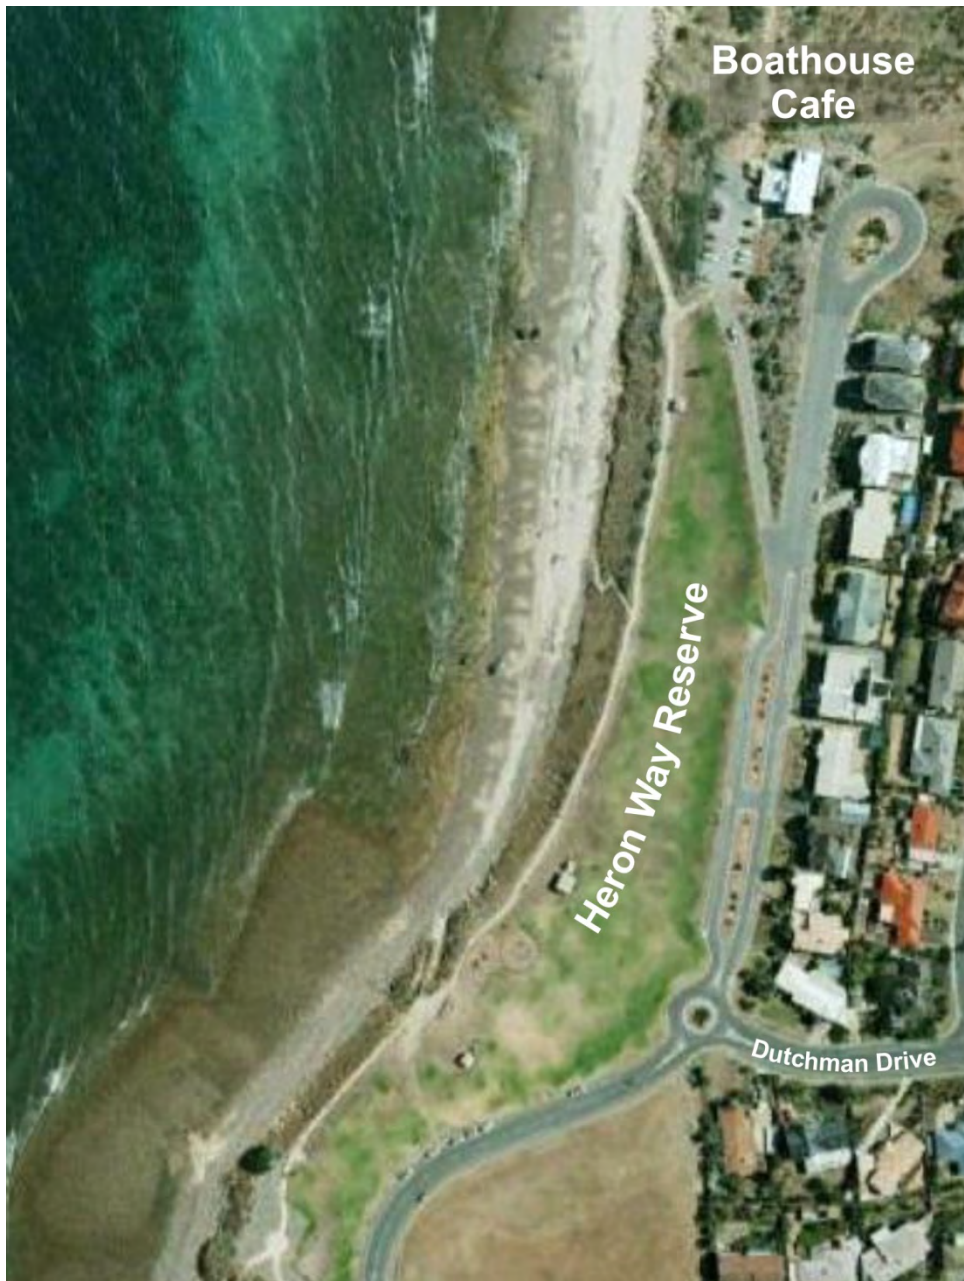
Beach Section 2 extends approximately 300m south from the boundary of the conservation area to approximately the location of the disused boat ramp near the end of Dutchman Drive. At the northern end, adjacent to the southern boundary of the conservation area, the foredune is high (approximately 10m AHD). The car park and Boatshed Café are located landward of the crest and there is a steep embankment from the dune crest to the beach at a slope of approximately 1V to 3H. At the base of the slope, erosion of the lower bank has left a vertical and unstable slope along sections of the beachfront to the south.

**Plate 4-7:** Section 2 Conservation Area to centre of Heron Way Reserve. This section of the beach extends approximately 300m south from the southern boundary of the Hallett Cove Conservation Area to the boat ramp seaward of the Dutchman Drive roundabout. **Photo source:** Google Earth image based on aerial photography 25 March 2010

At the southern end of the car park, a concrete access path to the beach runs across the dune face at an angle to the north. From the top of the bank, a concrete pedestrian path extends to the south along the embankment crest to the disused boat ramp approximately 250m to the south. This path forms the seaward edge of the Heron Way Reserve. Seats, play equipment and shelter sheds are adjacent to the path.

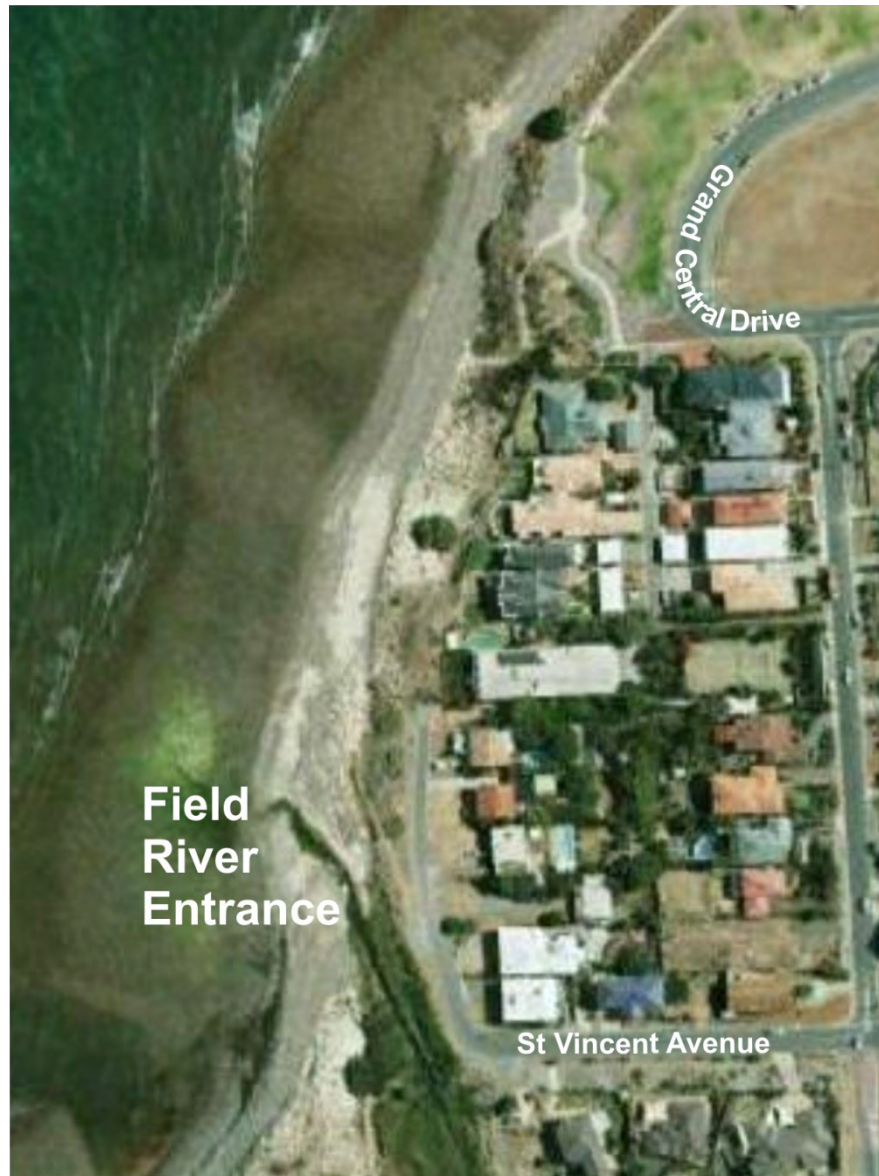
**Plate 4-8:** Section 3 Centre of Heron Way Reserve to the Field River entrance. **Photo source:** Google Earth image based on aerial photography 25 March 2010

Along this section, the beach is very narrow and the back beach protrudes seaward, protected in part by the exposed shingle and rock across the beach and in the swash zone. From the boat ramp, the dune height decreases to the south. The embankment slope remains very steep and erosion at the base has resulted in an unstable slope along this frontage. At Grand Central Drive, the foredune is significantly lower, reverting to a narrow and low sandy dune cap. The foreshore path ends at this location with access provided to the beach. The low dune continues to the south, reducing in height and width until the Field River entrance.

Beach Section 3 extends south from the disused boat ramp in Heron Way Reserve (now converted to provide pedestrian access via stairs to the beach) for a distance of approximately 400m, to the St Vincent Avenue corner with River Parade on the northern side of the Field River, just upstream of the entrance.

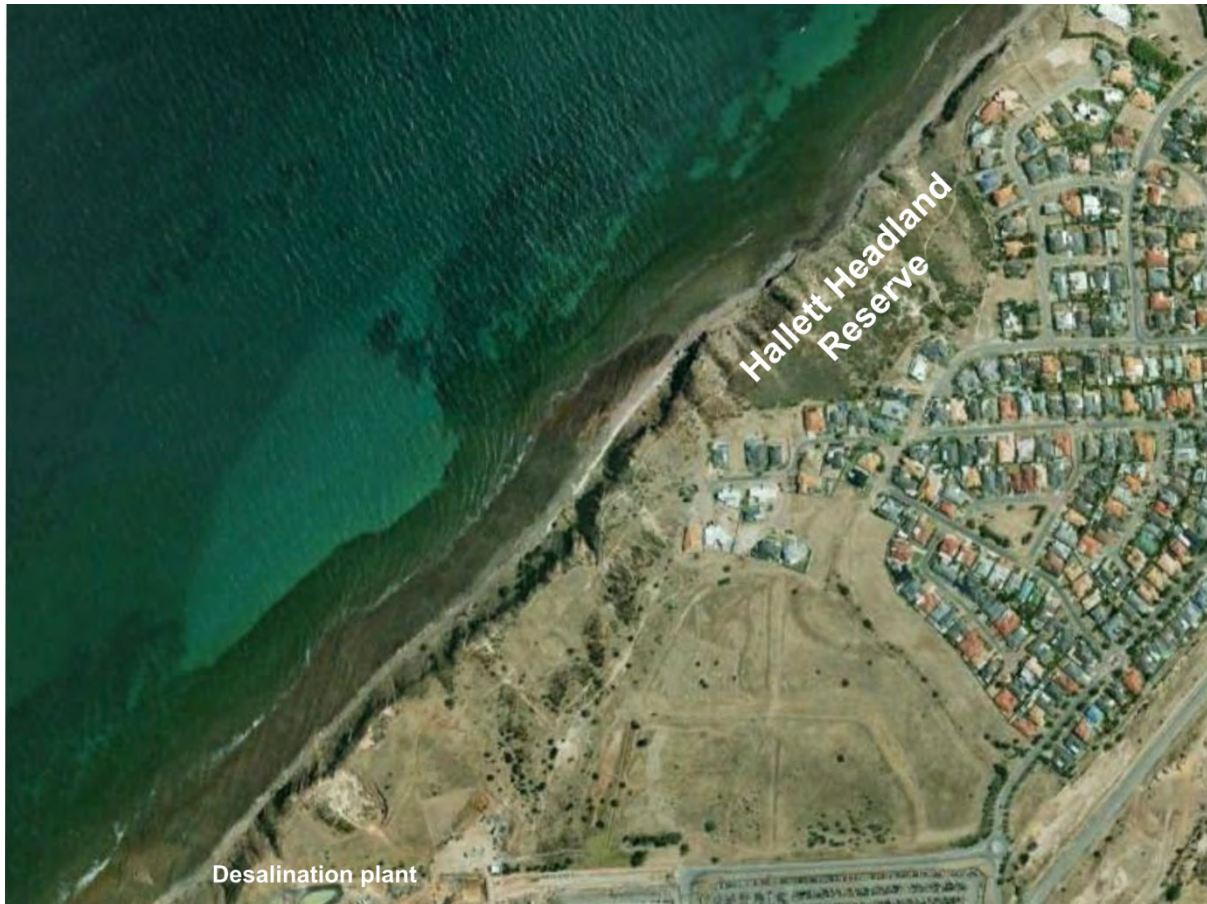
Beach Section 5 is the Hallett Headland, south from the first residential development on Albatross Walk to the desalination plant boundary, a distance of approximately 1100m. This includes the Hallett Headland Reserve, located along the headland behind the cliff line and seaward of any residential development. The top of the cliff line is approximately 30m AHD along this section. The closest development and subdivision along Albatross Walk is more than 20m from the cliff line. Further to the south all existing development is more than 50m from the cliff line. The walking path follows the cliff line and for the most part is more than 10m from the cliff edge. At several locations, stormwater discharges to deep gullies which discharge across the cliffs.

**Plate 4-10:** Section 5 Hallett Headland, Albatross Walk to the desalination plant boundary. **Photo source:** Google Earth image based on aerial photography 25 March 2010

Given the cliff elevation, sea level rise is not an issue and is unlikely to impact significantly on this section of the coast. By 2100, it is likely the wave cut platform below the cliff will be inundated more frequently, allowing wave action directly against the base of the cliffs. Routine monitoring of the cliff condition and stability (in particular the discharge of stormwater) should be undertaken.

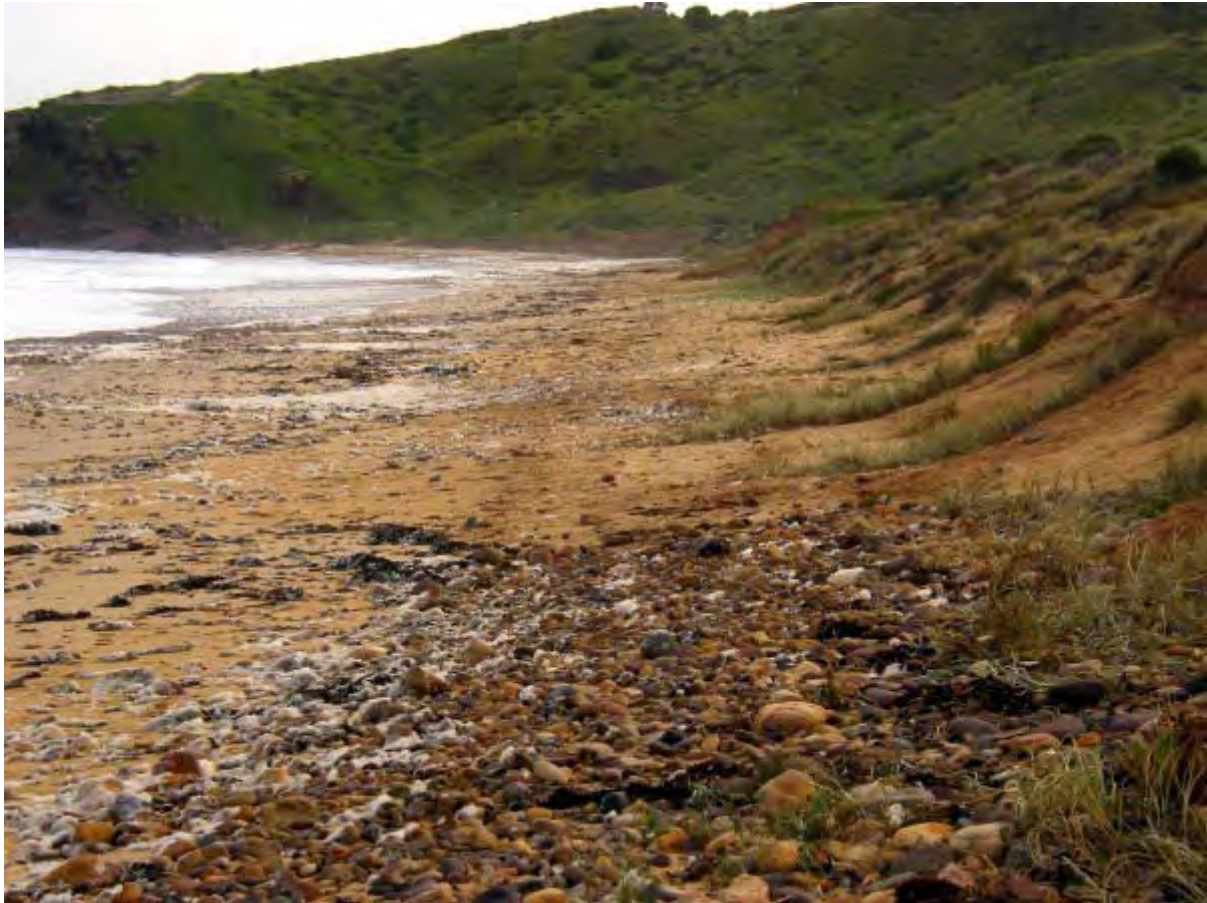
**Plate 6-1:** Beach Section 1, Hallett Cove Conservation Area. The beach is backed by a low dune which is eroded from time to time during storms. Ongoing recession may be managed with dune revegetation works following storms in the immediate future. **Photo source:** Coastal Environment Pty Ltd 18 August 2011

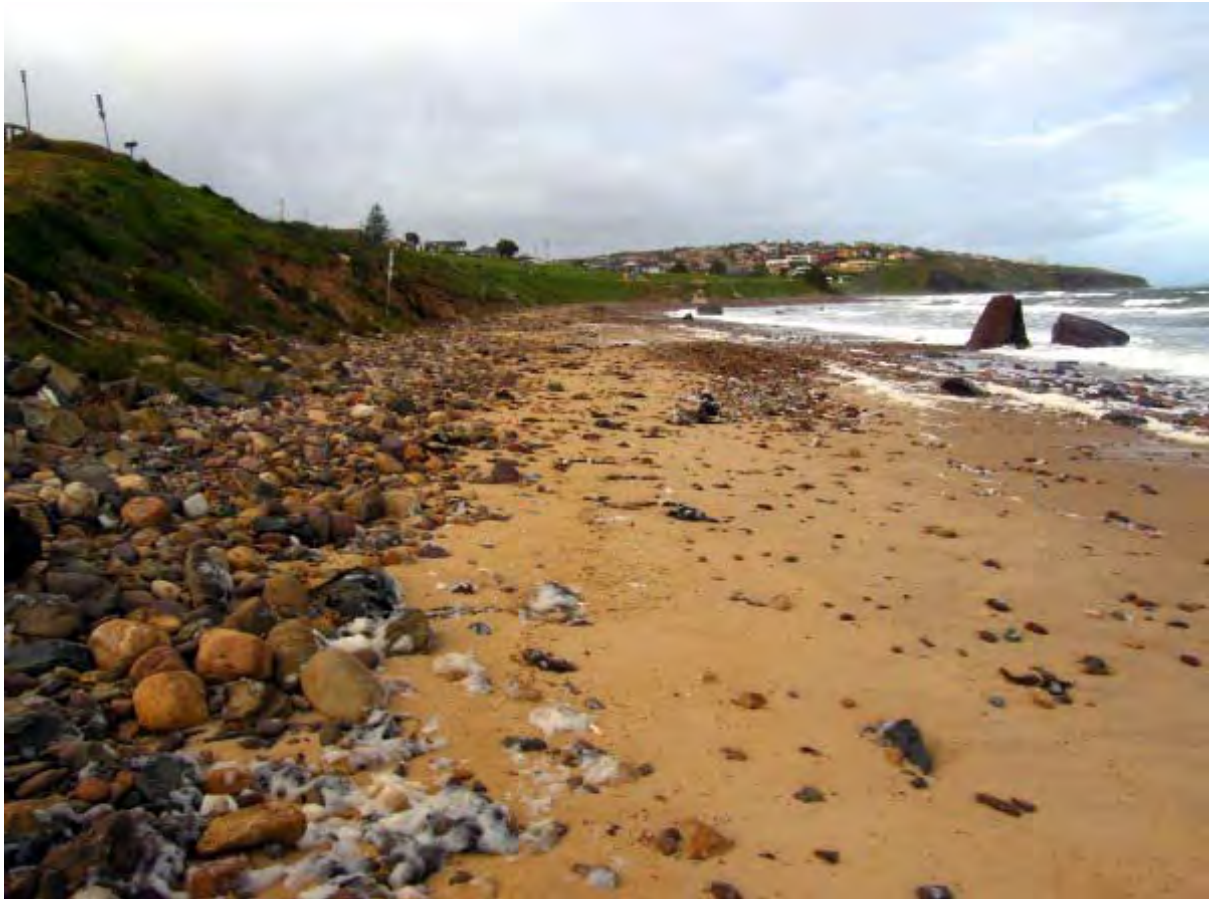
**Plate 6-2:** Beach Section 2, seaward of Heron Way Reserve. Along this section the beach is narrower and the erosion is forming a high unstable escarpment which needs to be addressed. **Photo source:** Coastal Environment Pty Ltd 18 August 2011

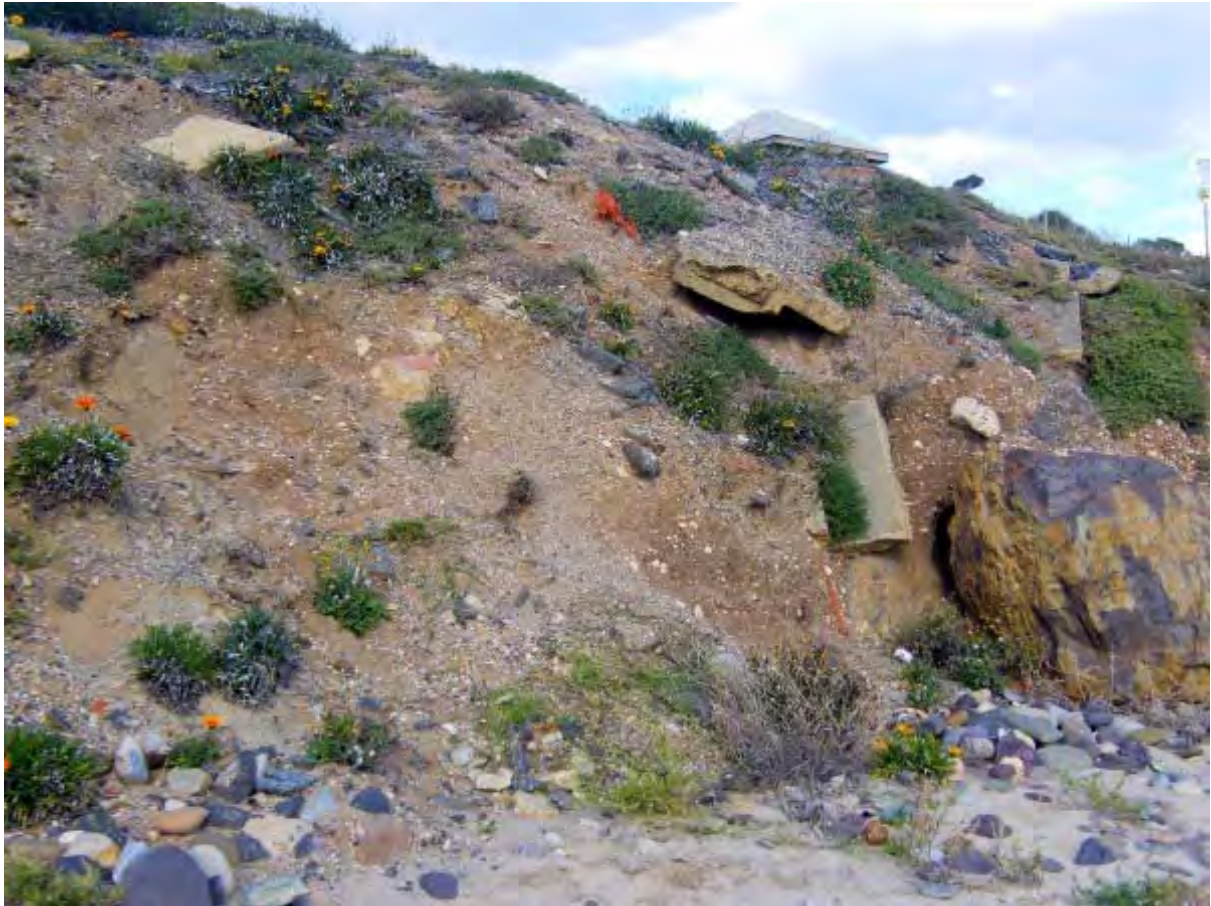
**Plate 6-3:** Beach Section 2, seaward of Heron Way Reserve. Sections of the escarpment are slipping, with building waste and boulders dislodged on the slope posing a safety risk. **Photo source:** Coastal Environment Pty Ltd 27 April 2011

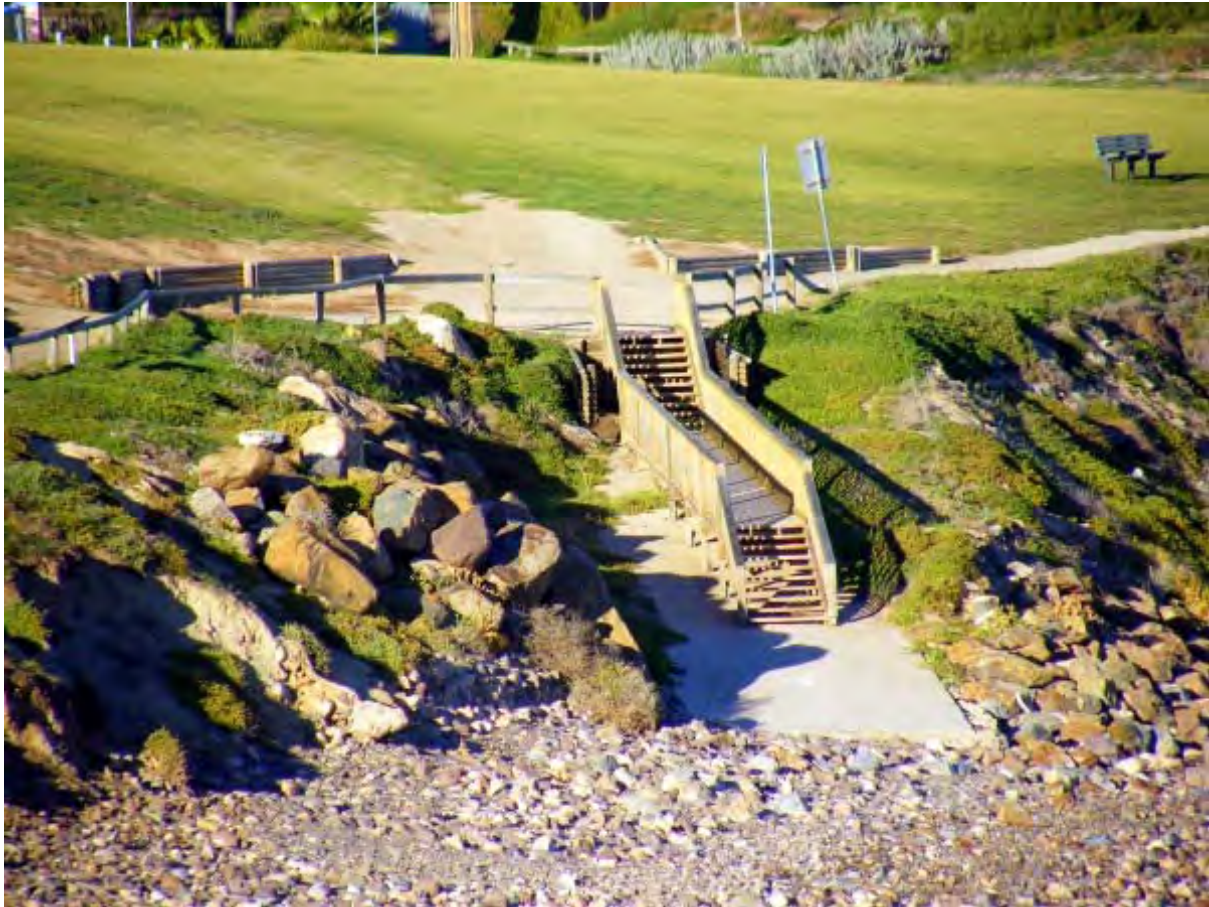
**Plate 6-4:** Beach Section 3, Heron Way Reserve to the Field River entrance. The escarpment height reduces near the disused boat ramp. The slope adjacent to the access and stormwater outlet and to the south is unstable and requires regrading. **Photo source:** Coastal Environment Pty Ltd 2 June 2011
