# Coastal Management Study

## Hallett Cove, SA

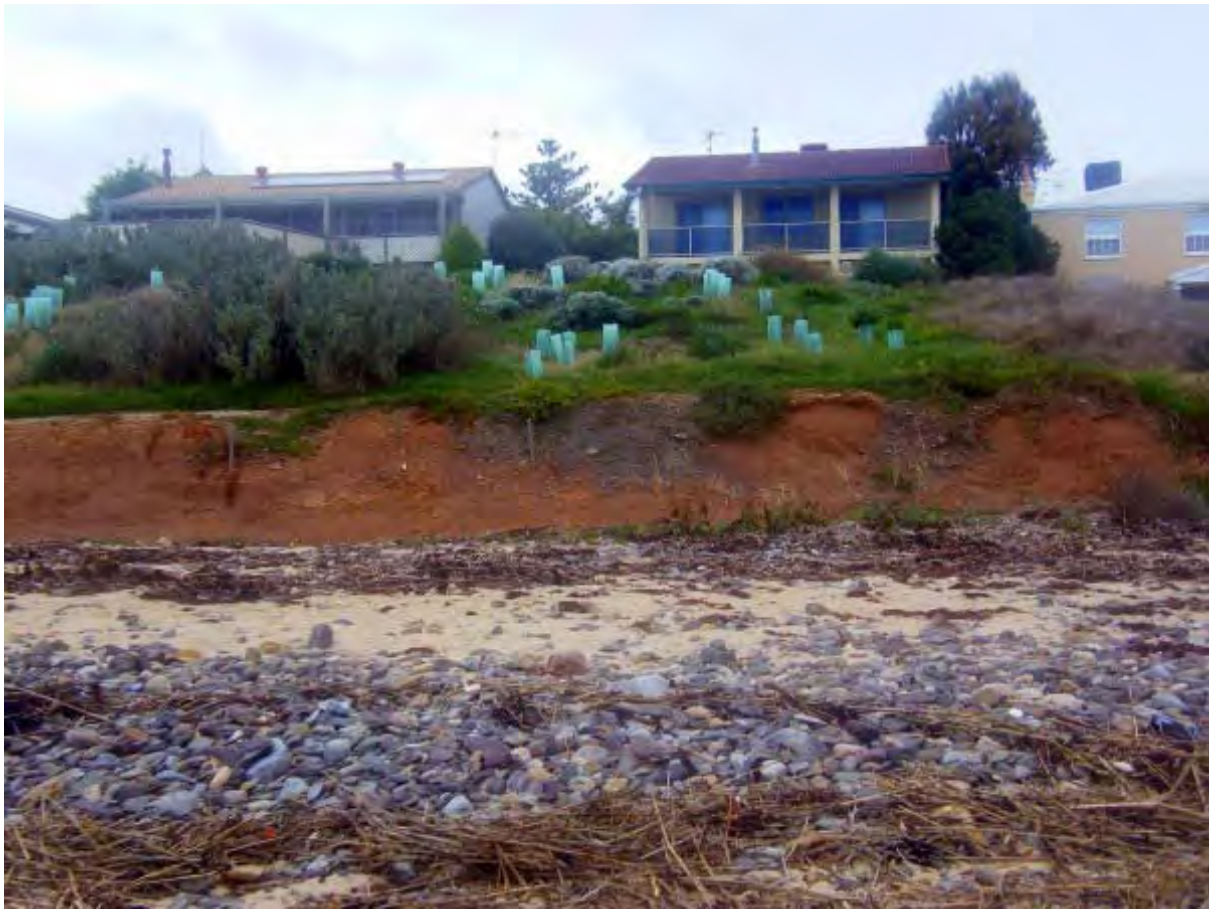
**Plate 6-5:** Beach Section 3, Heron Way Reserve to the Field River entrance. Erosion has removed the dune seaward of the Field River entrance in front of the residences facing River Parade. **Photo source:** Coastal Environment Pty Ltd 18 August 2011

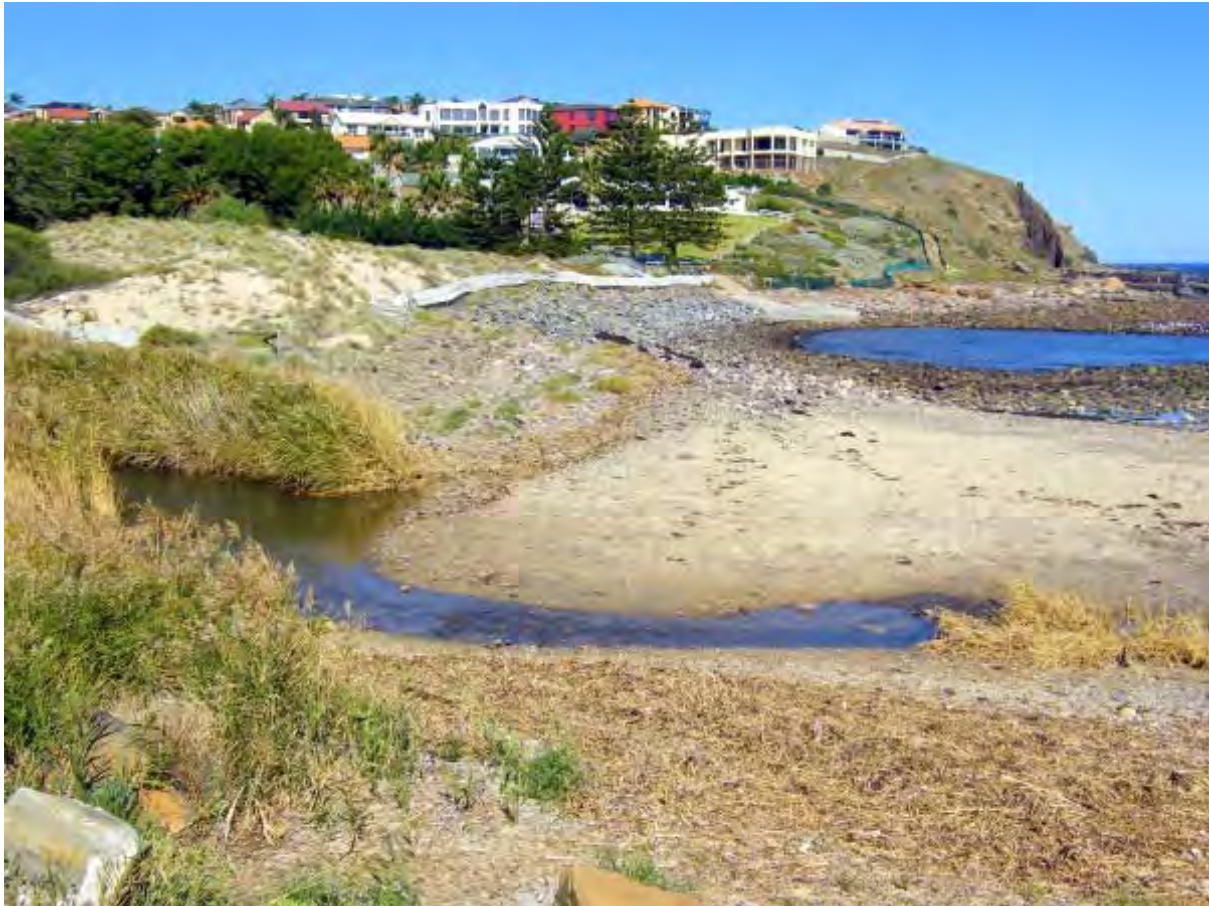
**Plate 6-6:** Beach Section 4, Field River entrance to the southern cliffs. The narrow dune cap on the southern side of the river is at the left between the concrete boat ramp and the river entrance. The deeper water in the boat channel on the right allows larger waves to erode further up the beach during storms. **Photo source:** Coastal Environment Pty Ltd 27 April 2011

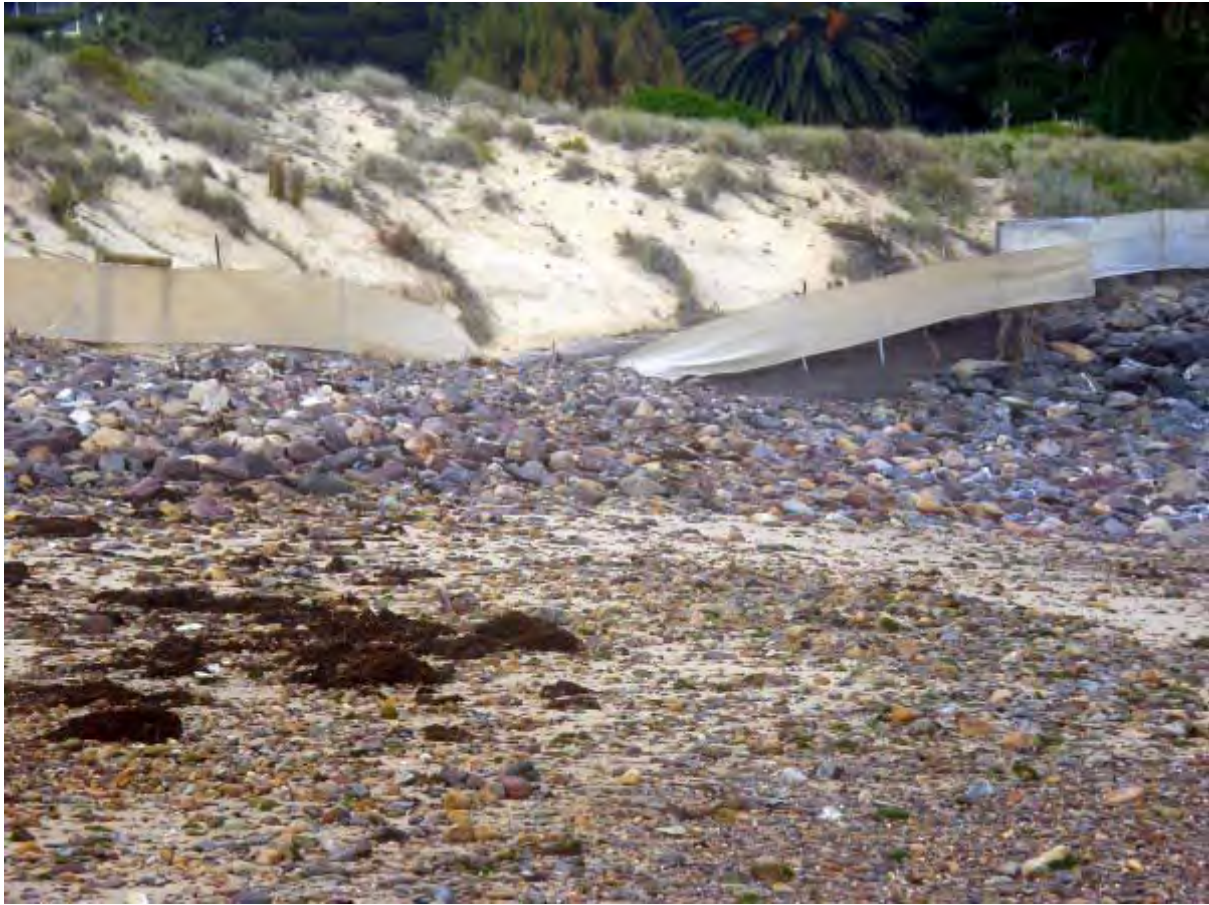
**Plate 6-7:** Beach Section 4, Field River entrance to the southern cliffs. The narrow dune cap on the southern side of the river has been eroded and is now protected by quarry stone placed at the rear of the beach. As sea level rises this dune cap and the subdivision behind will be increasingly at risk. **Photo source:** Coastal Environment Pty Ltd 18 August 2011

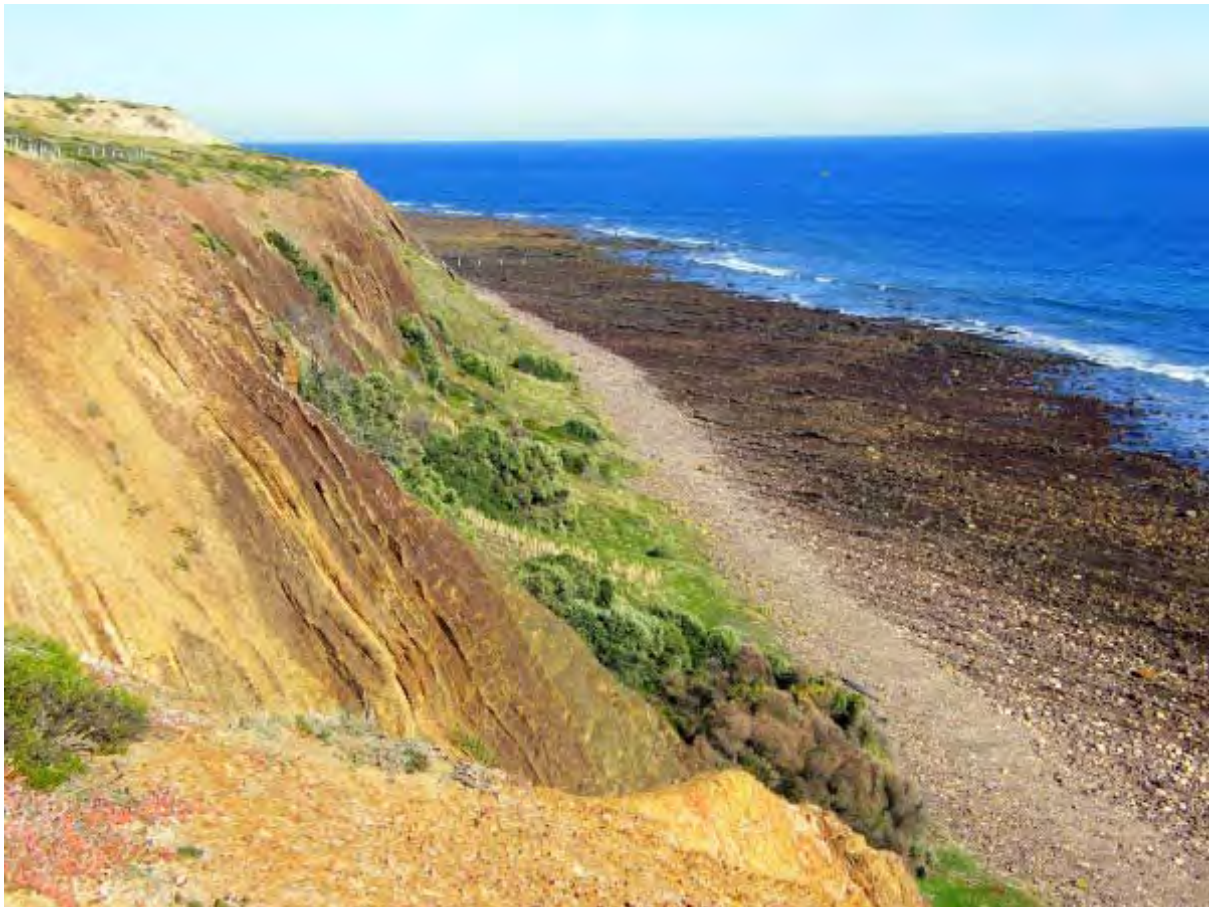
**Plate 6-8:** Beach Section 5, Hallet Head to the southern City of Marion boundary. The near vertical bedrock cliffs are fronted by a low, wave cut platform with little or no sand at the base of the cliffs. Development is sited well back from the cliff line. **Photo source:** Coastal Environment Pty Ltd 2 June 2011

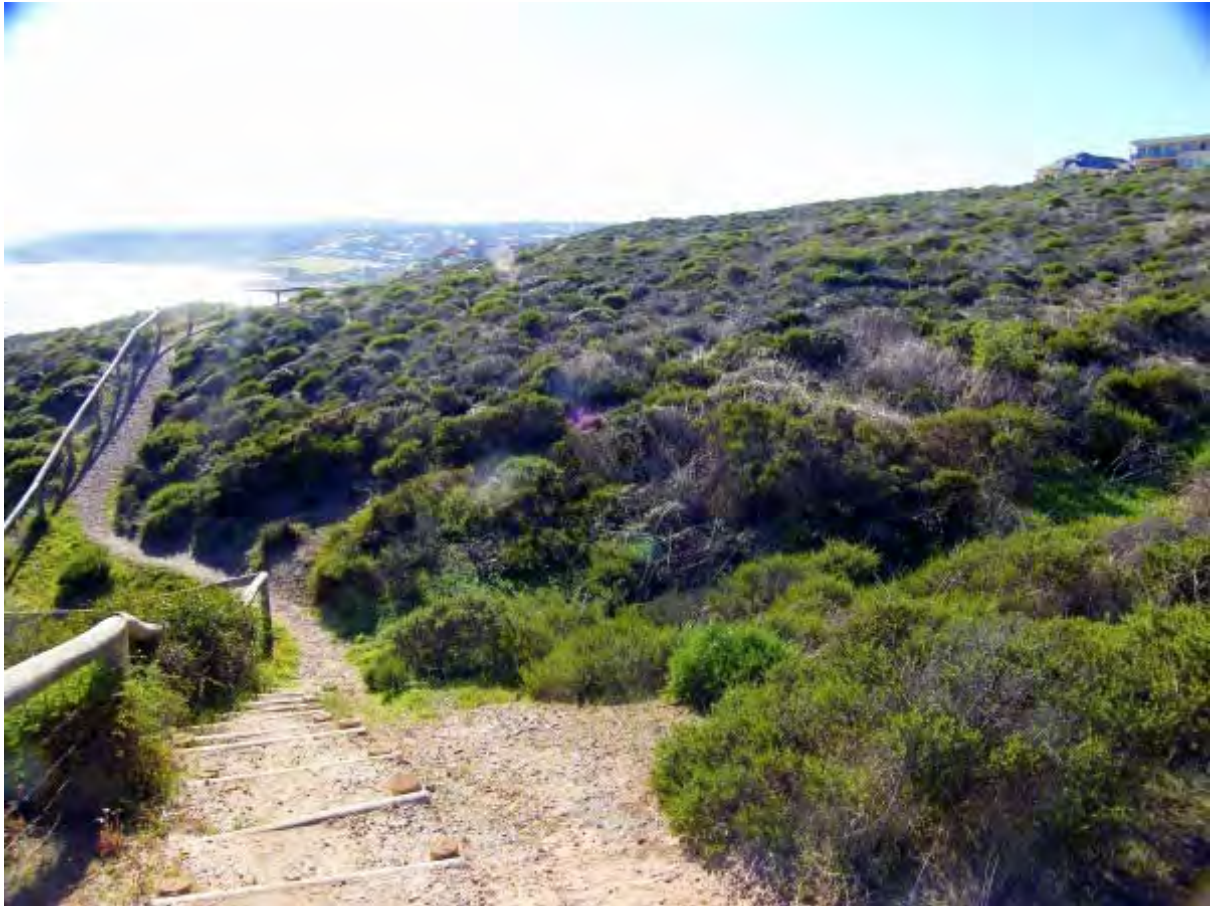
**Plate 6-9:** Beach Section 5, Hallet Head to the southern City of Marion boundary. The trail along the cliff passes through the unique vegetation of Hallett Head Reserve and provides excellent views over Hallett Cove to the north. Residential development is sited well back from the cliff line. **Photo source:** Coastal Environment Pty Ltd 2 June 2011

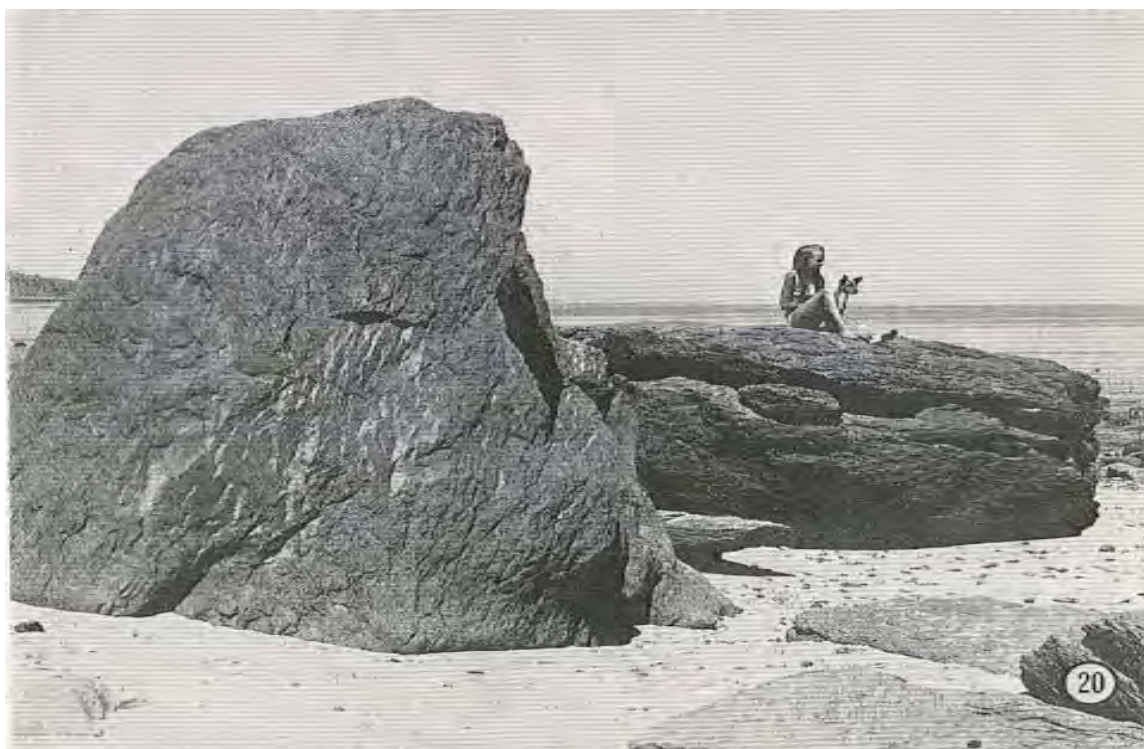
**Plate B-13:** Erratics seaward of the Boatshed Café circa 1970

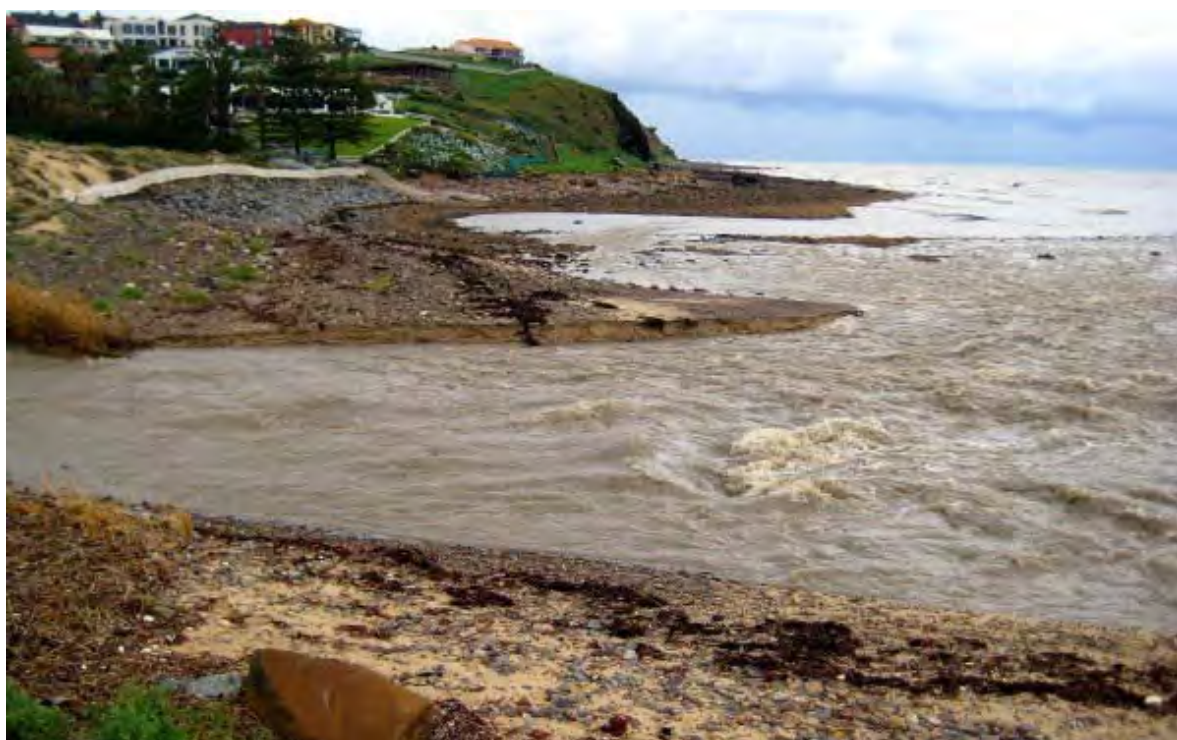
**Plate B-14:** Field River flood 29 June 2010

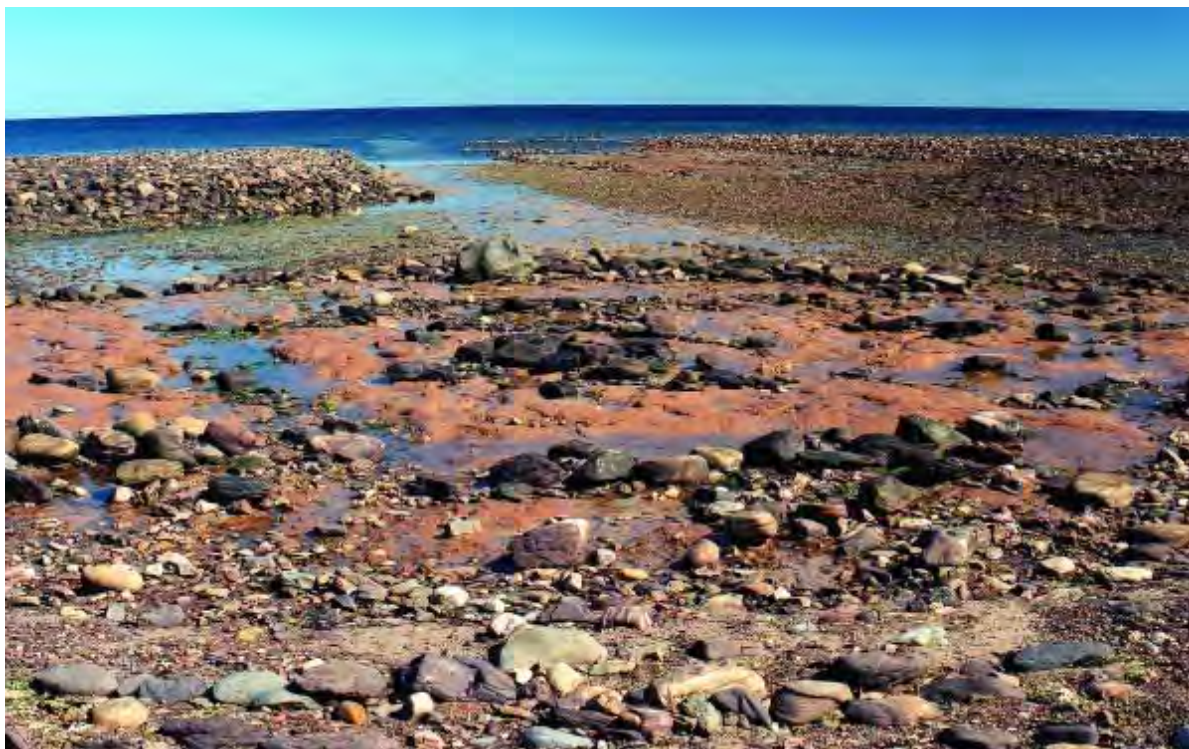
**Plate B-15:** Exposed clay, Field River entrance March 2005

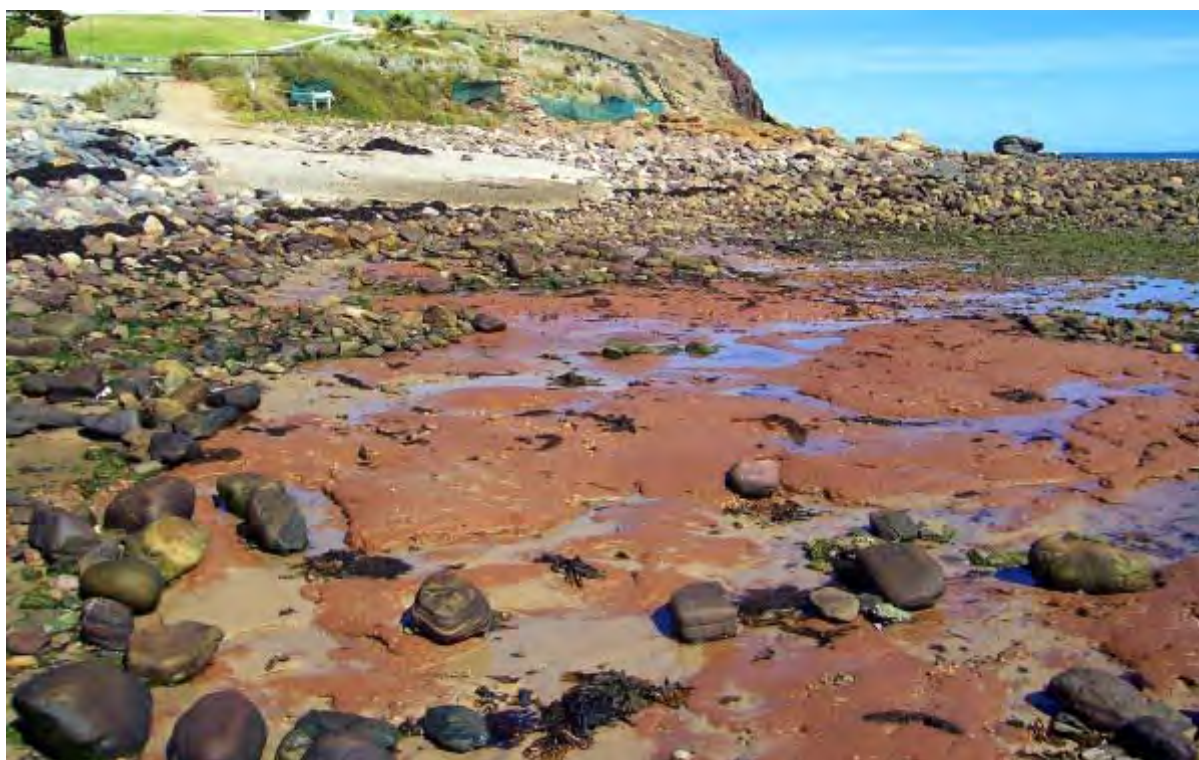
**Plate B-16:** Exposed clay, Field River entrance 18 May 2006

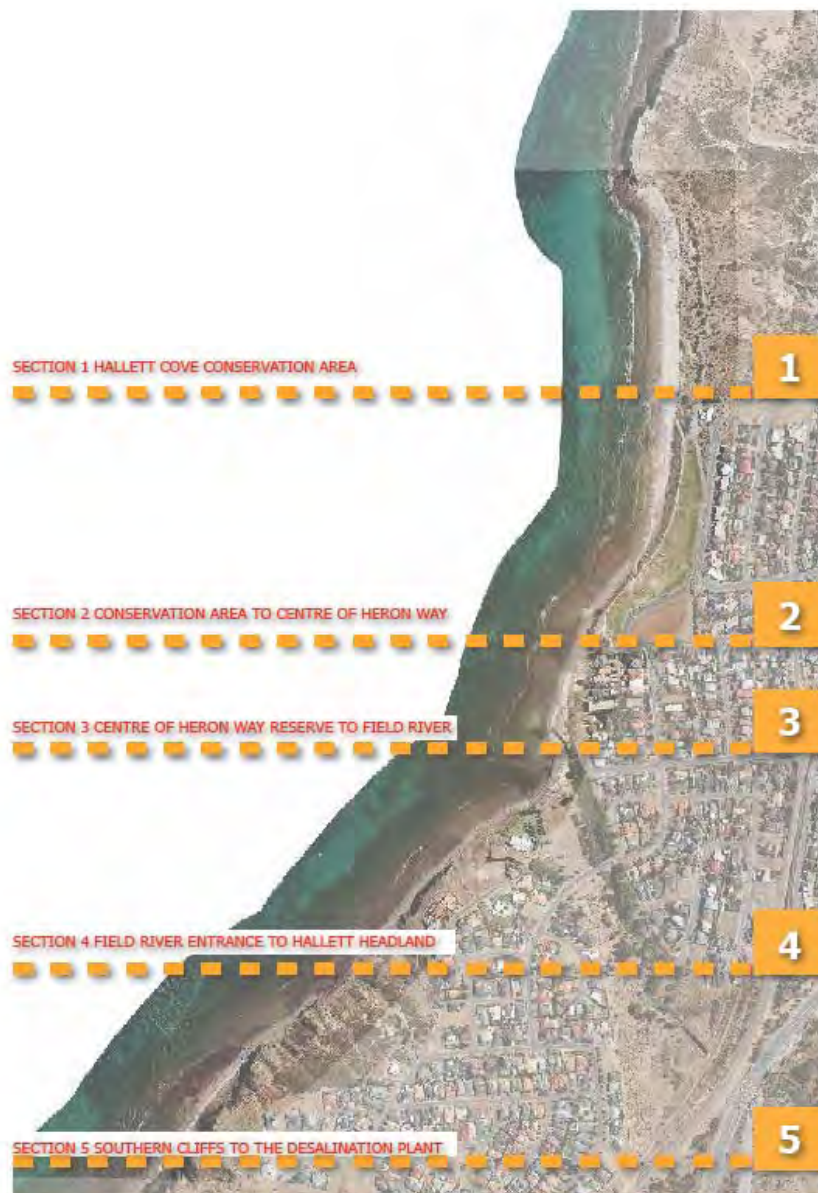
**Plate C-1:** The Hallet Cove Study area addressed in this Management Plan

This management plan covers the Hallett Cove foreshores within the City of Marion, bounded by the southern end of Hallett Cove Beach adjacent to Black Cliff within the Hallett Cove Conservation area and extending for approximately 2.5 kilometres south to the southern Boundary of the City of Marion, adjacent to the desalination plant on Hallett Headland. It includes the foreshore and foredune of Hallett Cove Beach within the conservation area and seaward of Heron Way Reserve, the Field River entrance and adjacent coastal foreshores; and the cliff line of Hallett Headland.

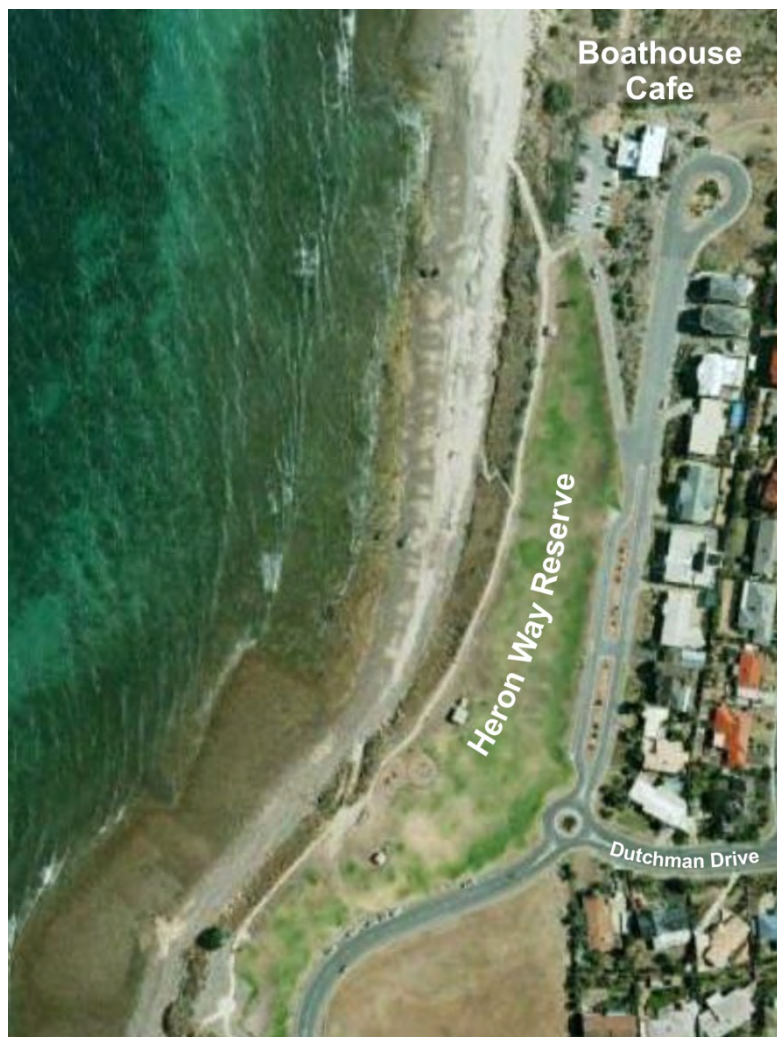
**Plate C-3:** Beach Section 2 extends 300 metres from the southern boundary of the conservation area to the centre of Heron Way Reserve at the old boat ramp seaward of the Dutchman Drive roundabout. **Photo source:** Google Earth image based on aerial photography 25 March 2010

Repair and/or removal of the beach accessways, walking trail and stormwater assets may be necessary by 2050. Beyond 2050 a protection structure will be required through this precinct to secure existing development and assets. Additional studies to determine the composition of the back beach sediments and identify foundation conditions should be undertaken so an alignment for a revetment can be selected. The integrity of the beach face including the shingle cover should be maintained, with care taken not to expose the underlying clay or to remove shingle from the beach, particularly during works.

Initial allowance is to be included in the annual budget to support ongoing dune and revegetation works, geotechnical assessment and regrading of the eroded slope as required. The required budget allowance will increase overtime as the beach recedes. Long-term funding sources will be needed for protection works to be implemented.

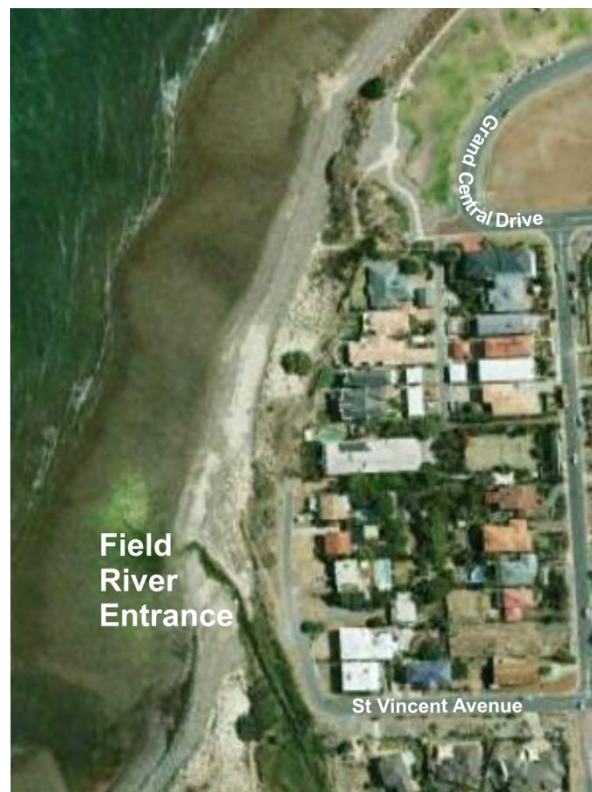
**Plate C-4:** Beach Section 3. This beach section extends 400 metres from the centre of Heron Way Reserve to the Field River entrance and includes the residential development along the beachfront and River Parade between Grand Central Avenue and St Vincents Avenue. **Photo source:** Google Earth image based on aerial photography 25 March 2010

Additional studies to determine the composition of the back beach sediments and identify foundation conditions should be undertaken so appropriate controls are in place for the residential subdivision behind the dune. In the longer term, additional armouring of the beach face may prolong the viability of this dune area. Importantly, the integrity of the existing beach face must be maintained, with care taken not to expose the underlying clay or to remove or relocate shingle from the beach as has occurred previously.

Initial allowance is to be included in the annual budget to support ongoing dune and revegetation works, geotechnical assessment of the back beach areas and possible armouring/sand nourishment of the beach face and dune cap using imported shingle/rock/sand as required. The budget allowance will increase over time as sea levels rise and erosion of the dune increases.

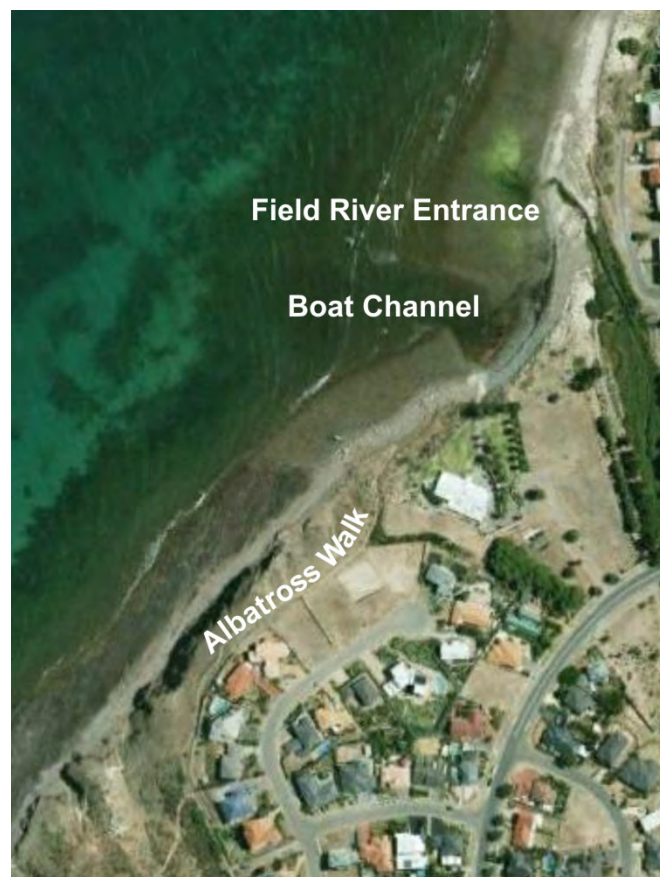
**Plate C-5:** Beach Section 4. This section extends from the Field River entrance approximately 300 m south to Hallett Headland and residential development on Albatross Walk. It includes the entrance sand dune cap at the Field River, residential subdivision north of Beachfront Crescent and the emergent bedrock cliff line to the top of the headland. **Photo source:** Google Earth image based on aerial photography 25 March 2010

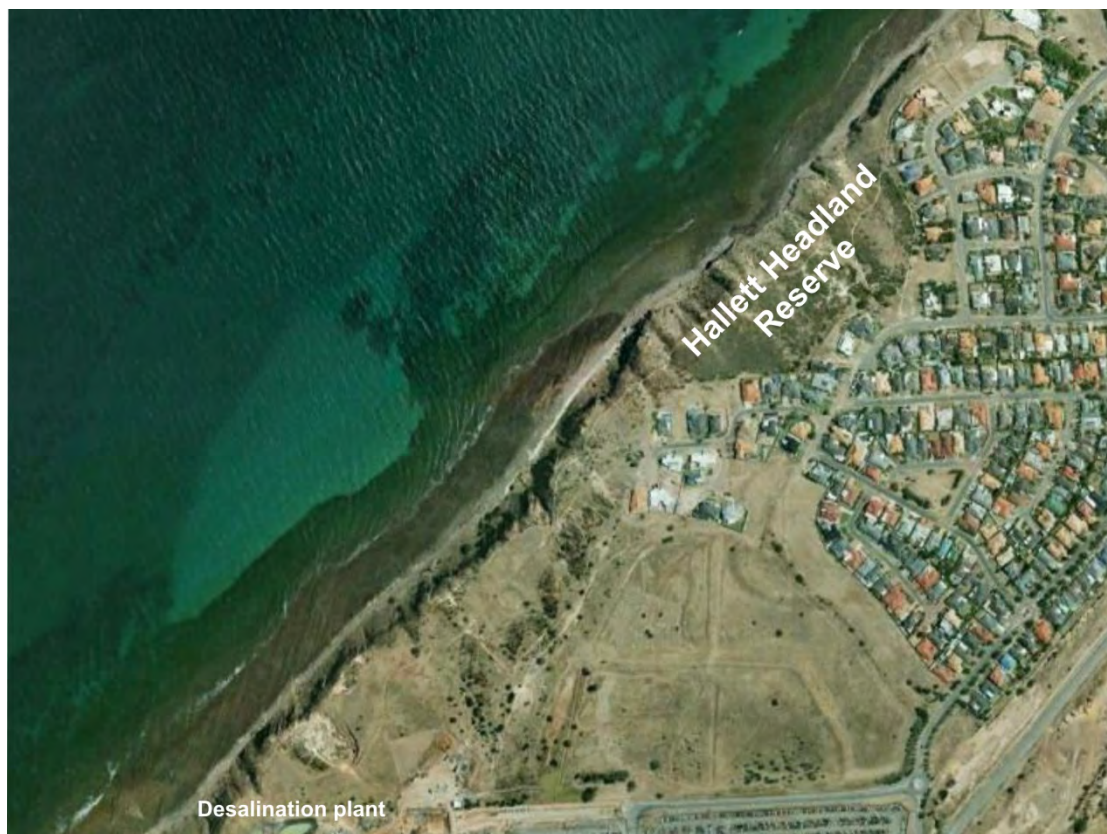
**Plate C-6:** Beach Section 5. The cliff line along Hallet Headland extends approximately 1,100 metres south from the residential development on Albatross Walk to the desalination plant at the southern boundary of the City of Marion. **Photo source:** Google Earth image based on aerial photography 25 March 2010

Geotechnical stability of the cliff face should be monitored over time.
